**Ben C. Gerwick, Inc.**  
Member of the COWI Group

Consulting Engineers  
1300 Clay Street, 7th Floor  
Oakland, CA 94612  
Tel. 510.839.8972  
Fax. 510.839.9715  
<http://www.gerwick.com/>

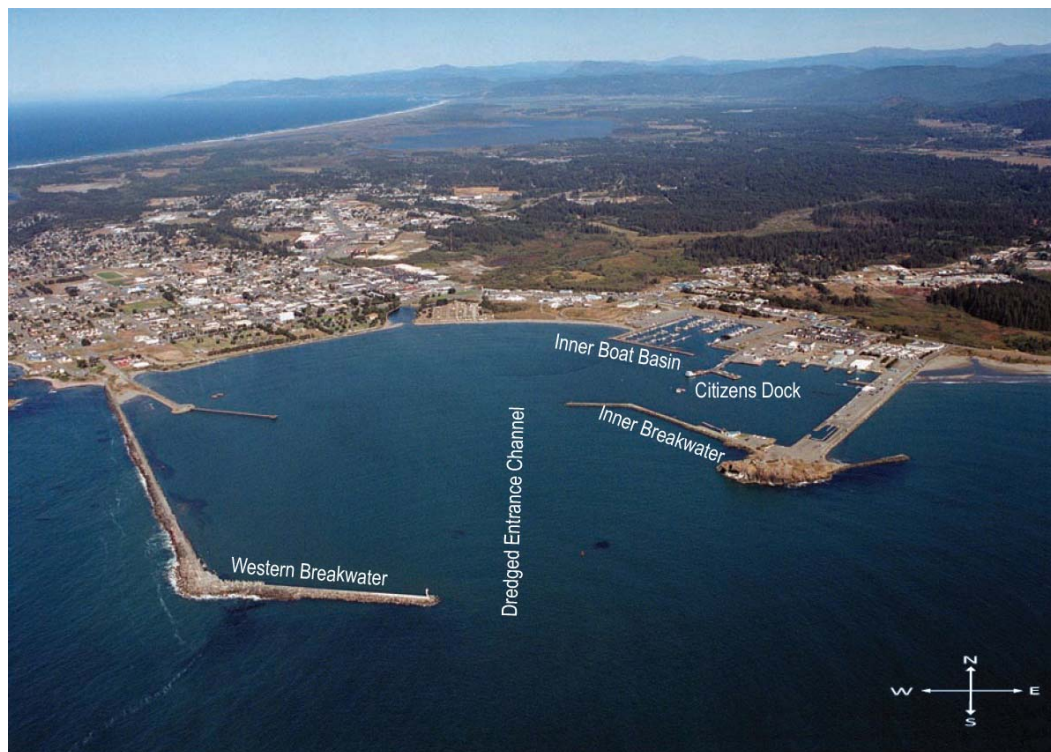
**Figure 1-1: Crescent City Harbor and Citizens Dock**

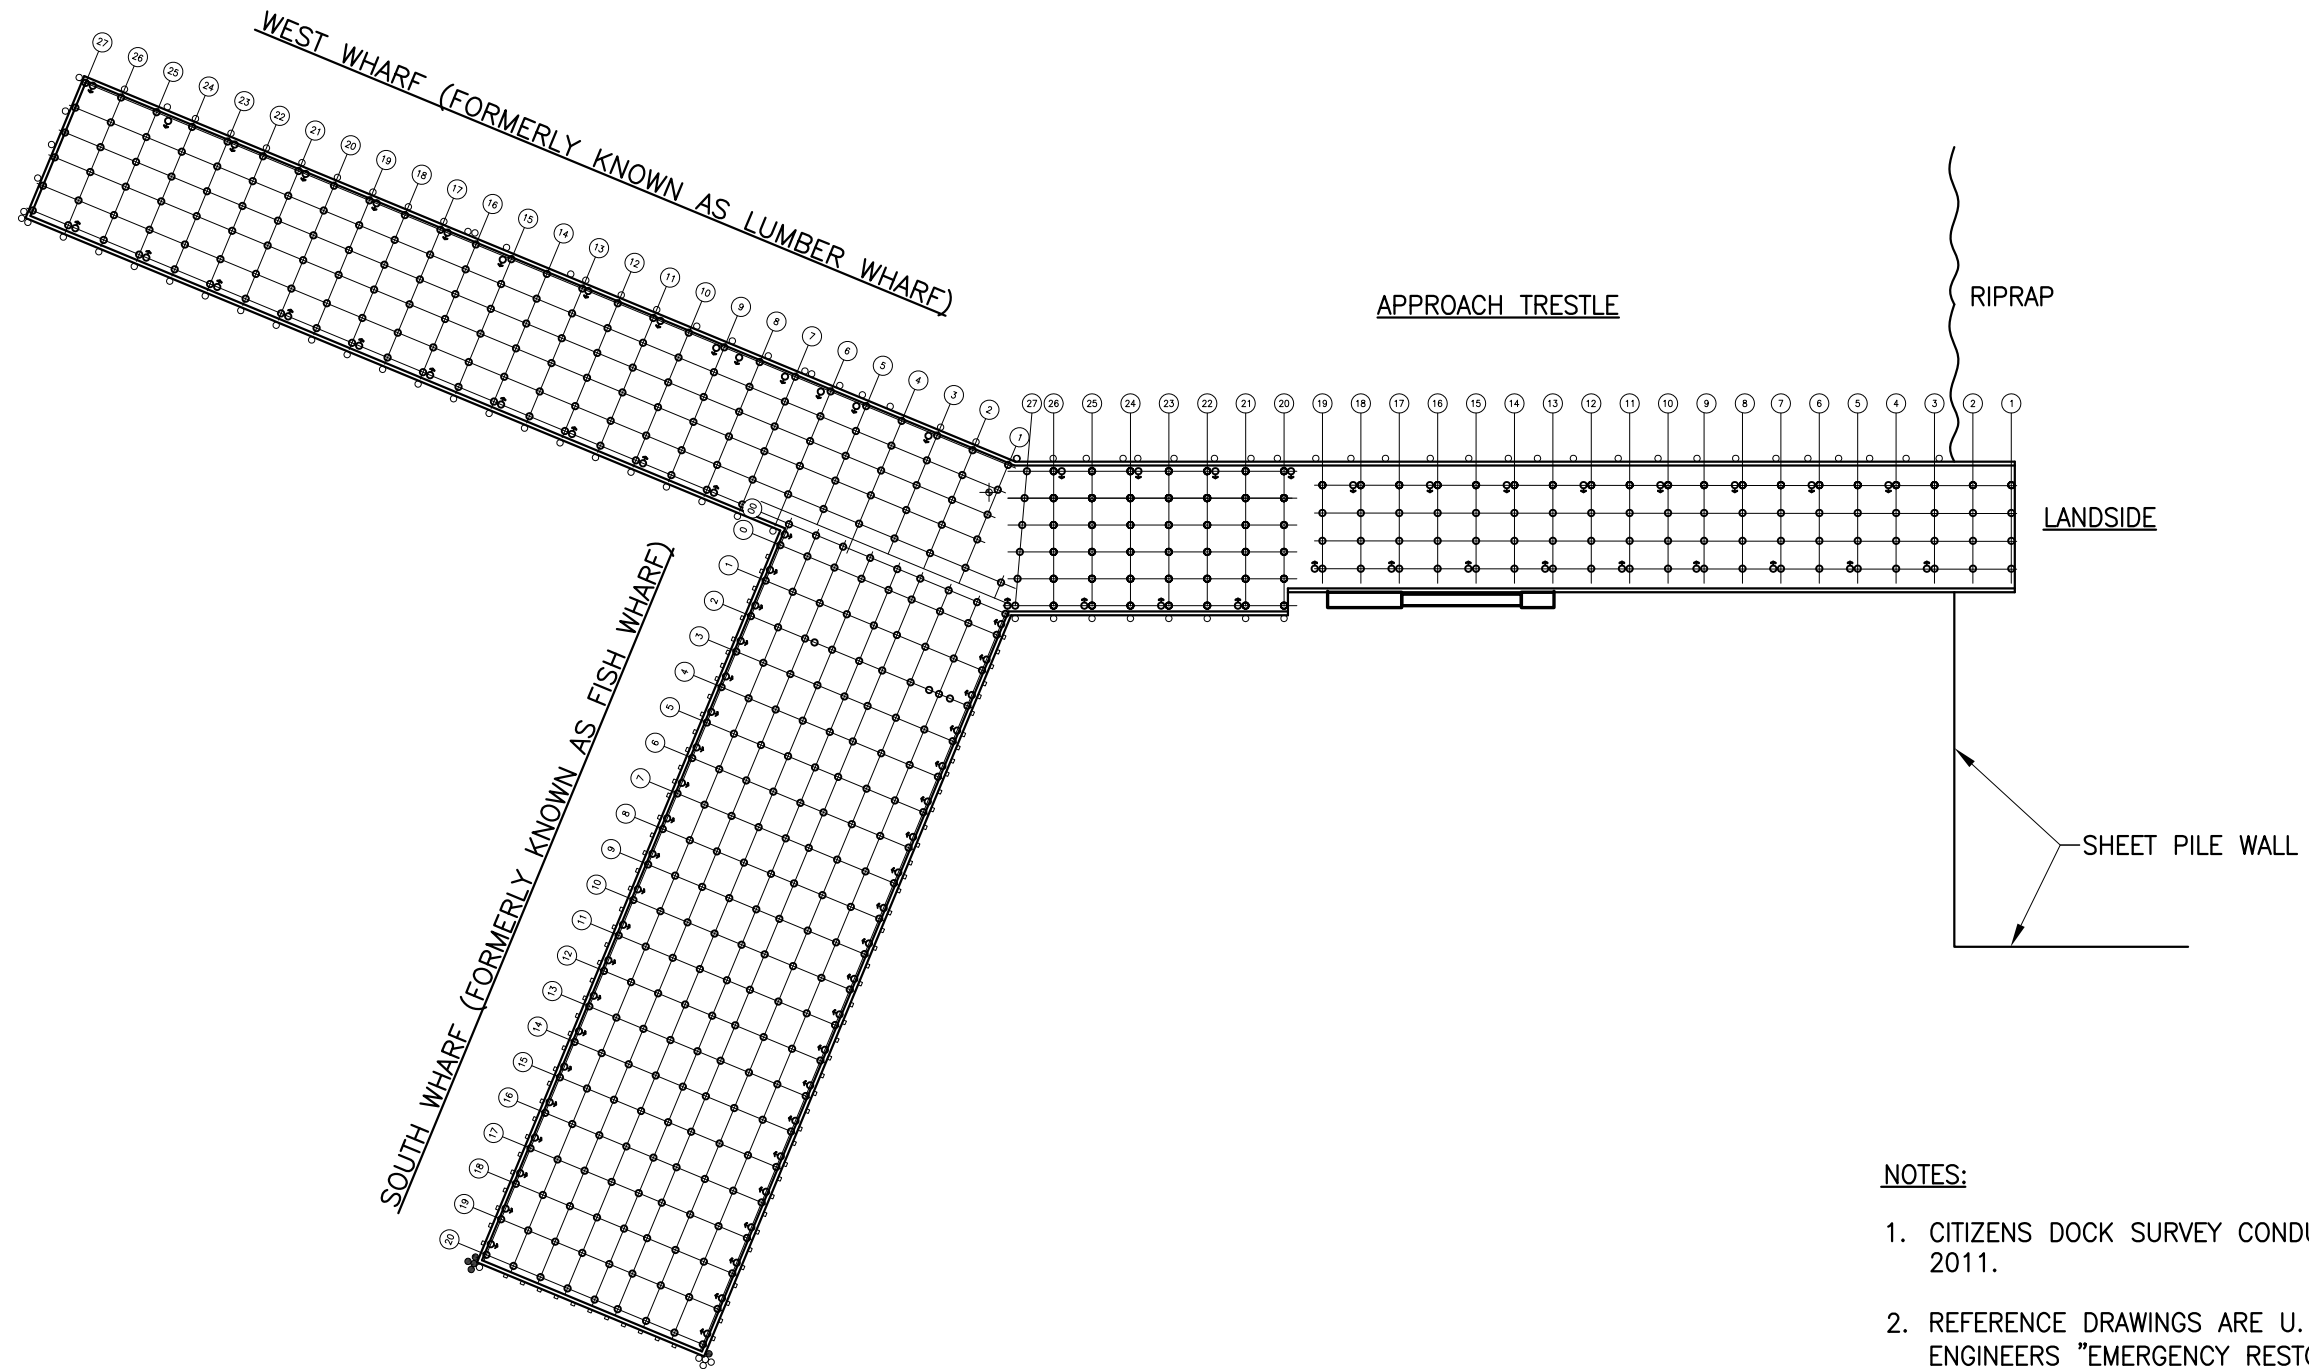
STOVER ENGINEERING SHALL NOT BE RESPONSIBLE FOR THE ACCURACY OR COMPLETENESS OF ELECTRONIC COPIES OF THIS PLAN SHEET.

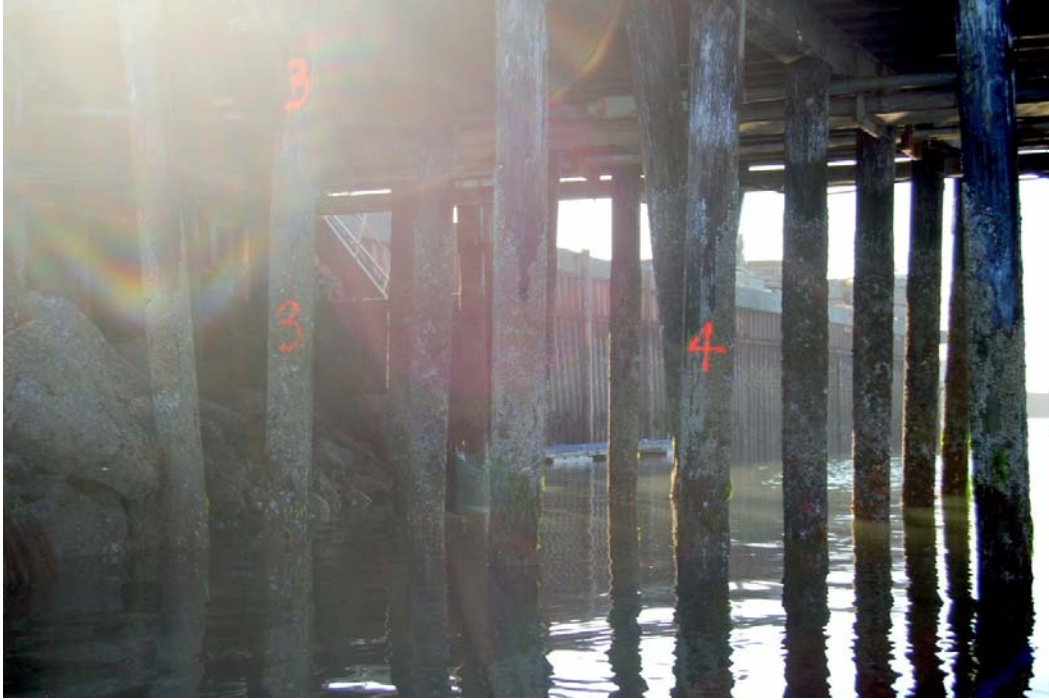
Approach Trestle Bents 3 to 4 (Photo #305)  
No damage noted

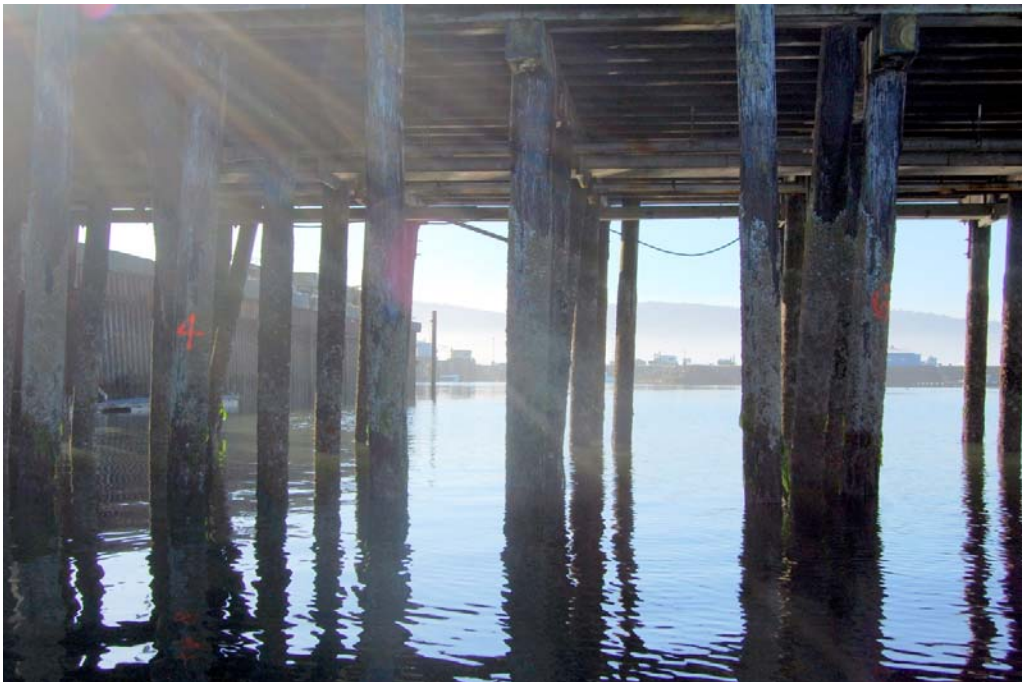
Approach Trestle Bents 4 to 6 (Photo #306)  
No damage noted

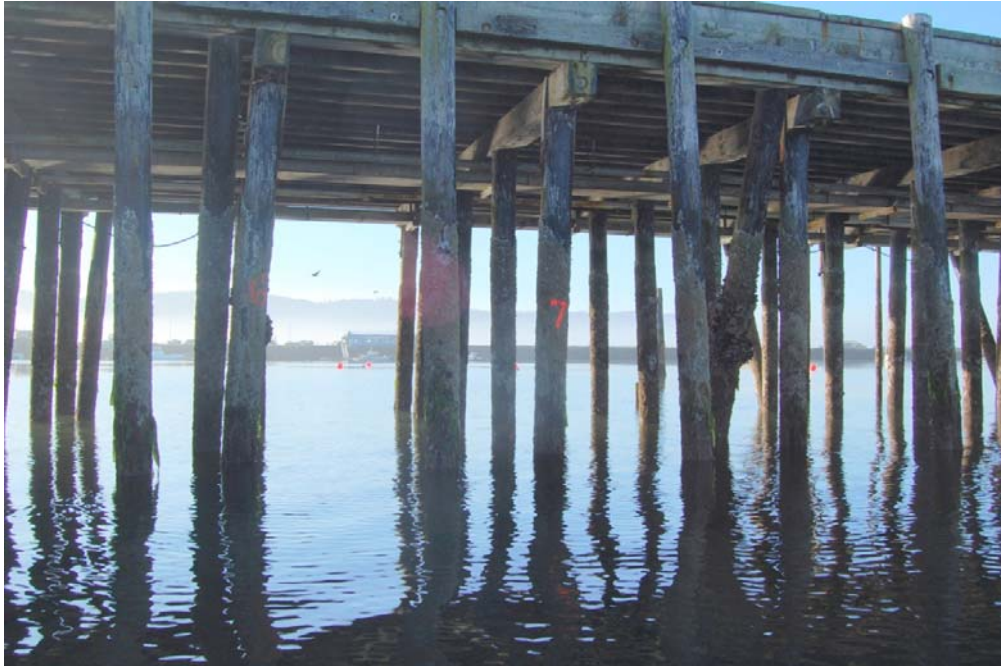
Approach Trestle Bents 6 to 8 (Photo #307)  
No damage noted

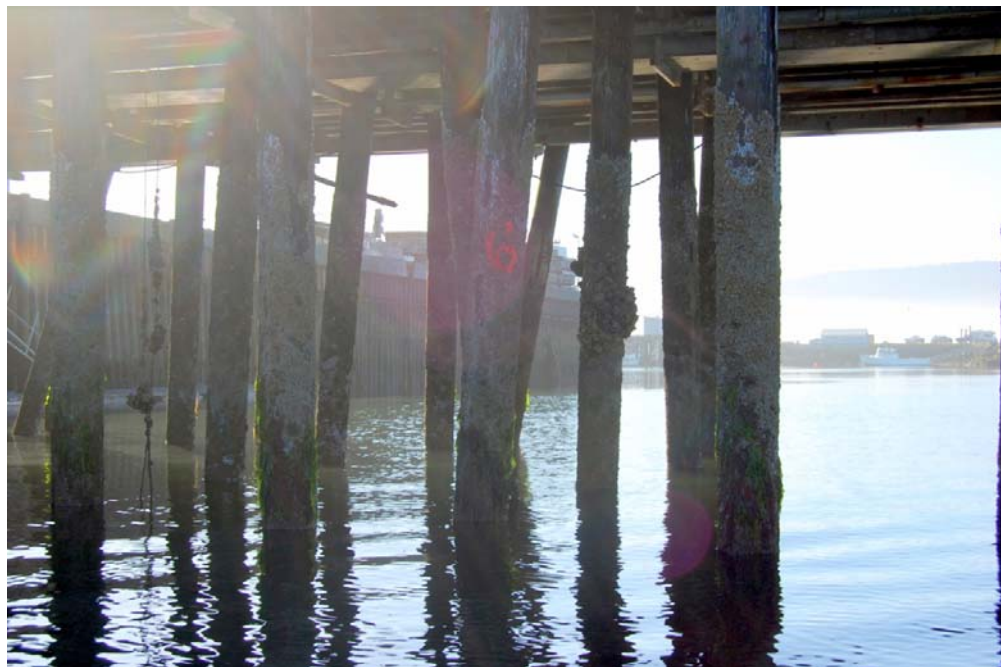
Approach Trestle Bent 6 (Photo #308)  
No damage noted

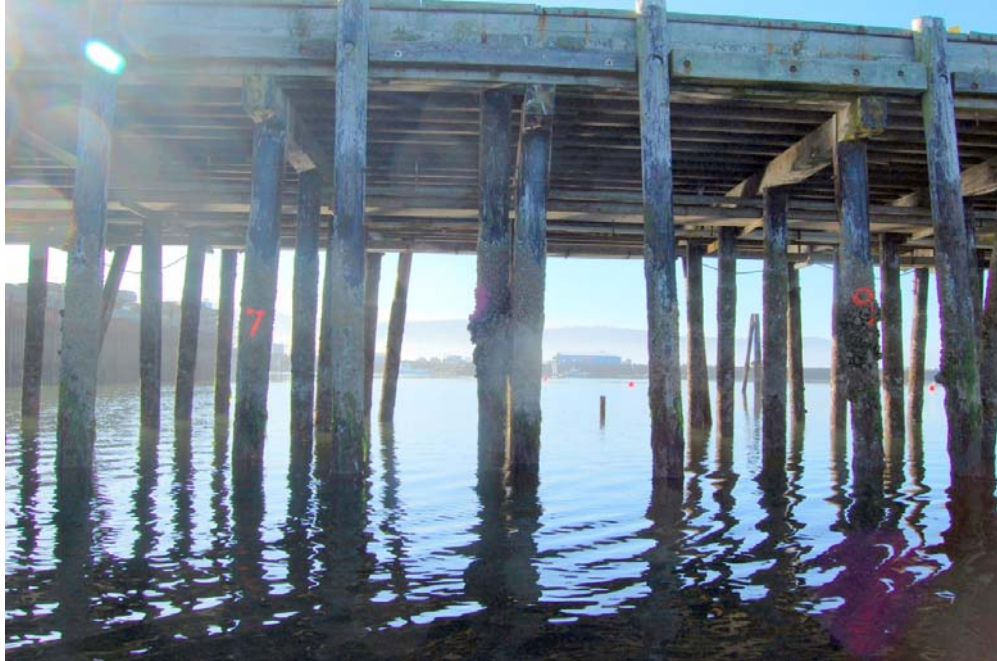
Approach Trestle Bents 7 to 9 (Photo #309)  
No damage noted

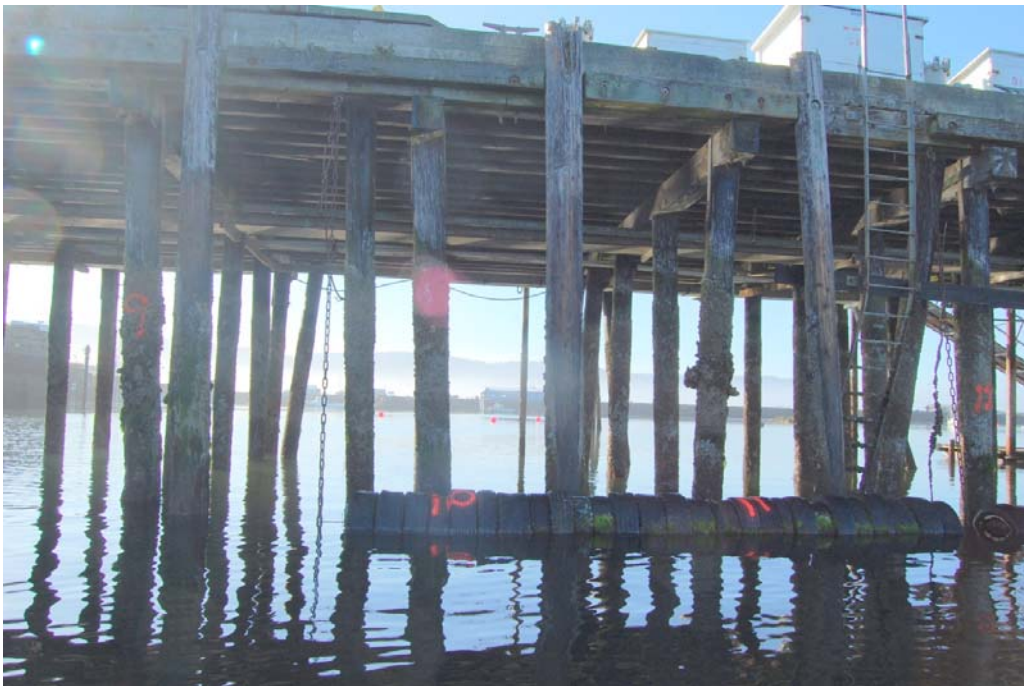
Approach Trestle Bents 9 to 12 (Photo #310)  
Bent steel ladder

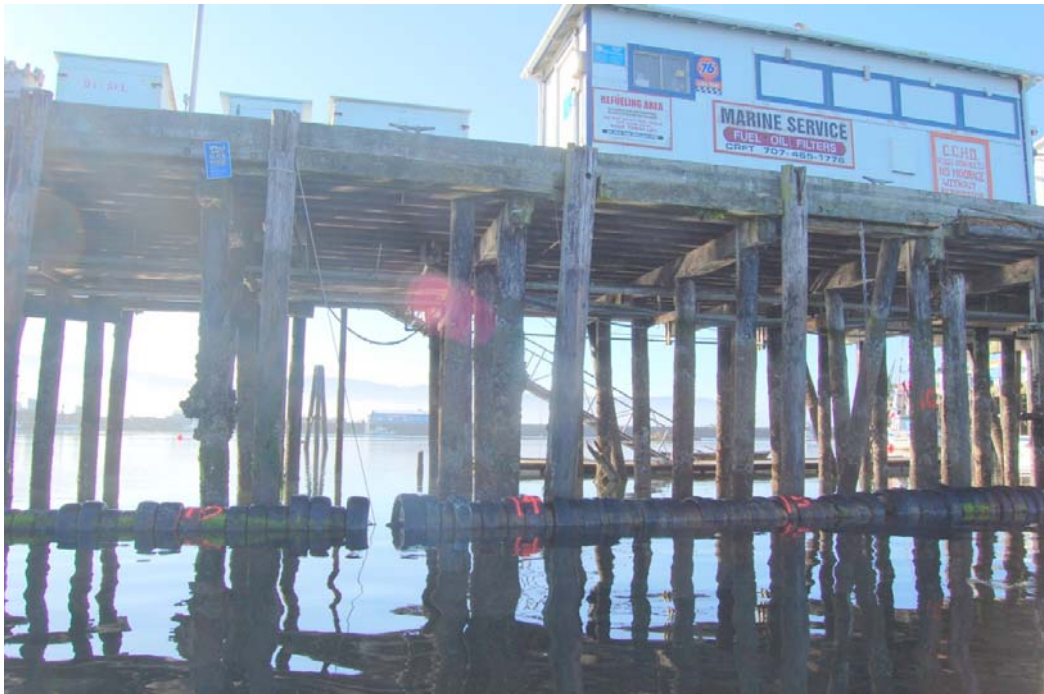
Approach Trestle Bents 13 to 16 (Photo #314)  
No damage noted, remove debris inside between Bents 14 & 15

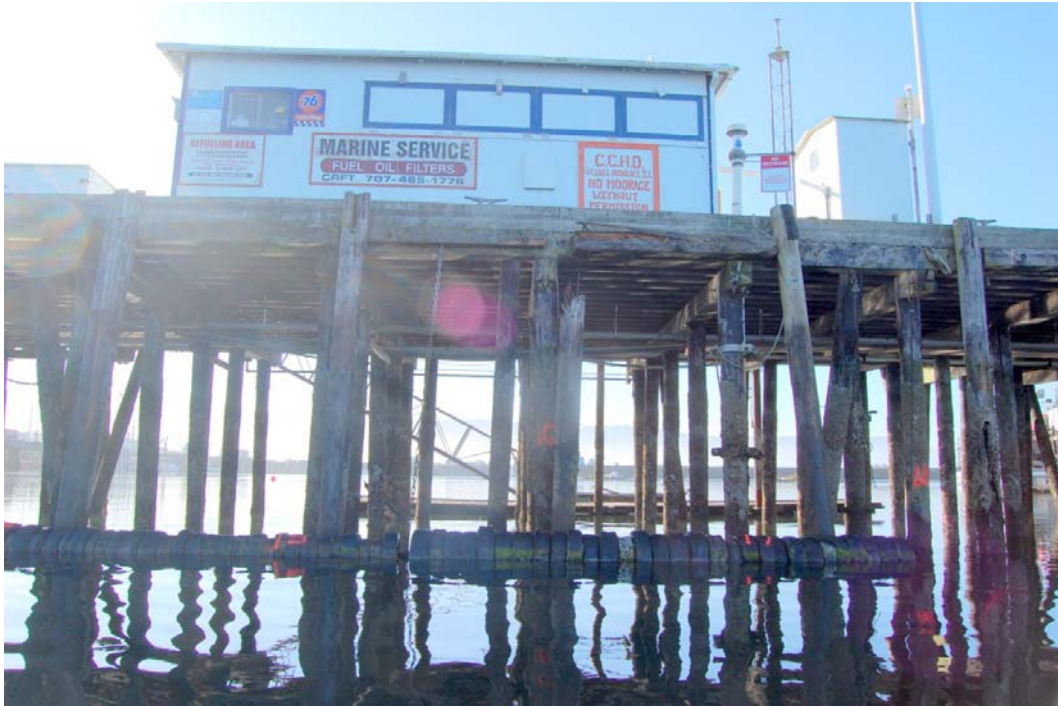
Approach trestle Bents 15 to 18 (Photo #316)  
Replace broken fender pile at Bent 16

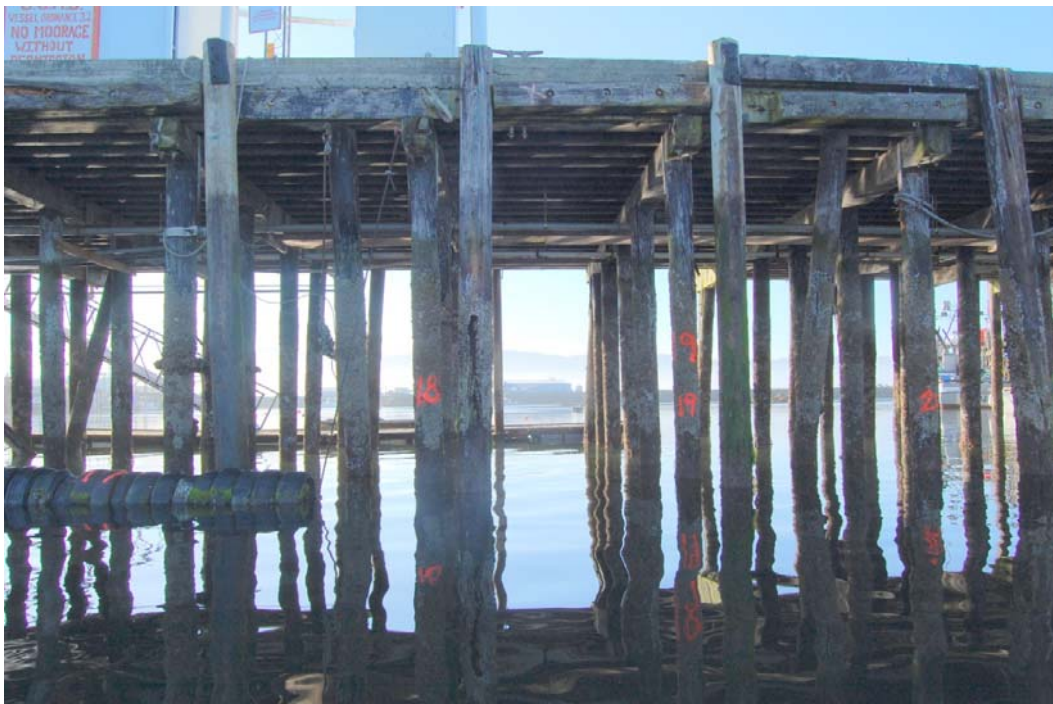
Approach Trestle Bents 17 to 20 (Photo #317)  
No damage noted

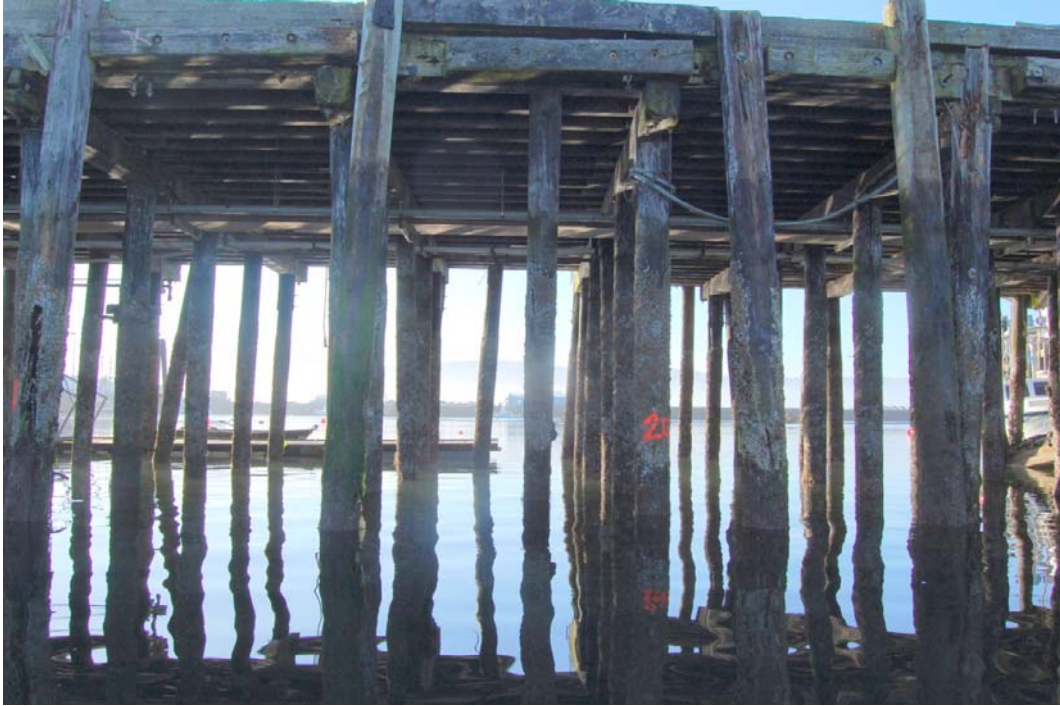
Approach Trestle Bents 19 to 20 (Photo #318)  
No damage noted

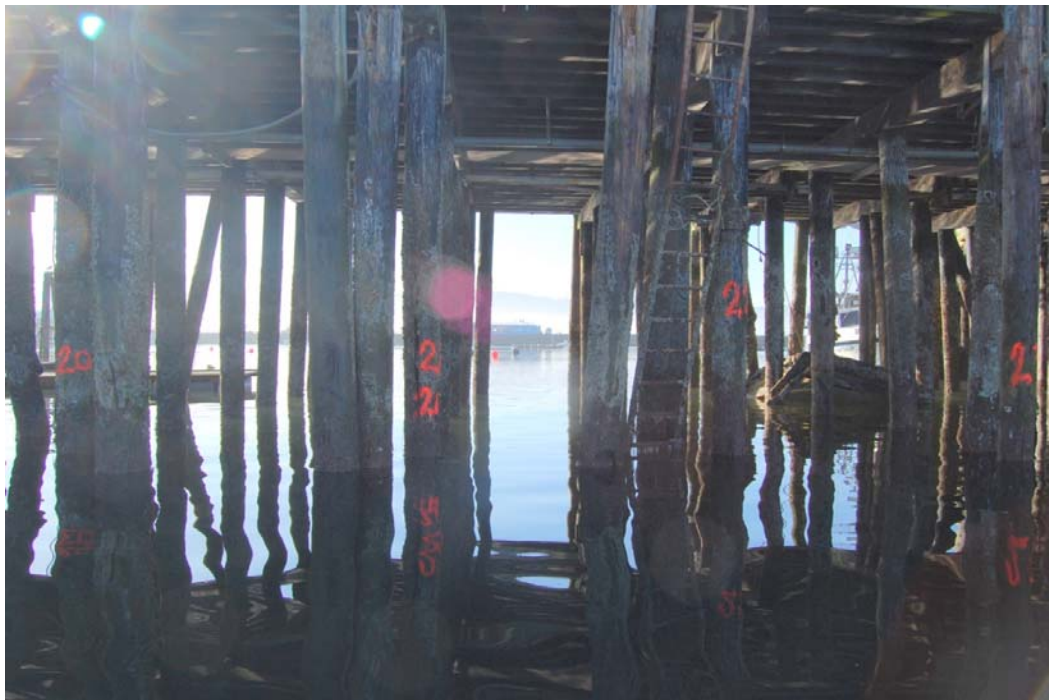
Approach Trestle Bents 20 to 23 (Photo #319)  
No damage noted, except bent ladder

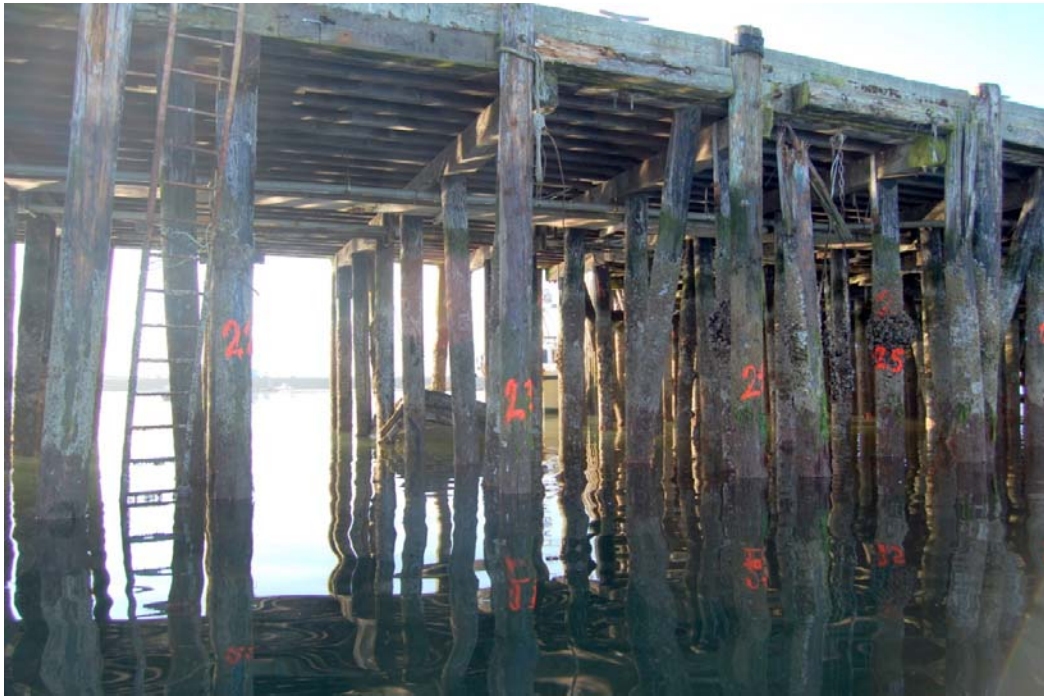
Approach Trestle Bents 22 to 25 (Photo #320)  
No damage noted, except bent ladder. Remove debris between Bents 23 & 24

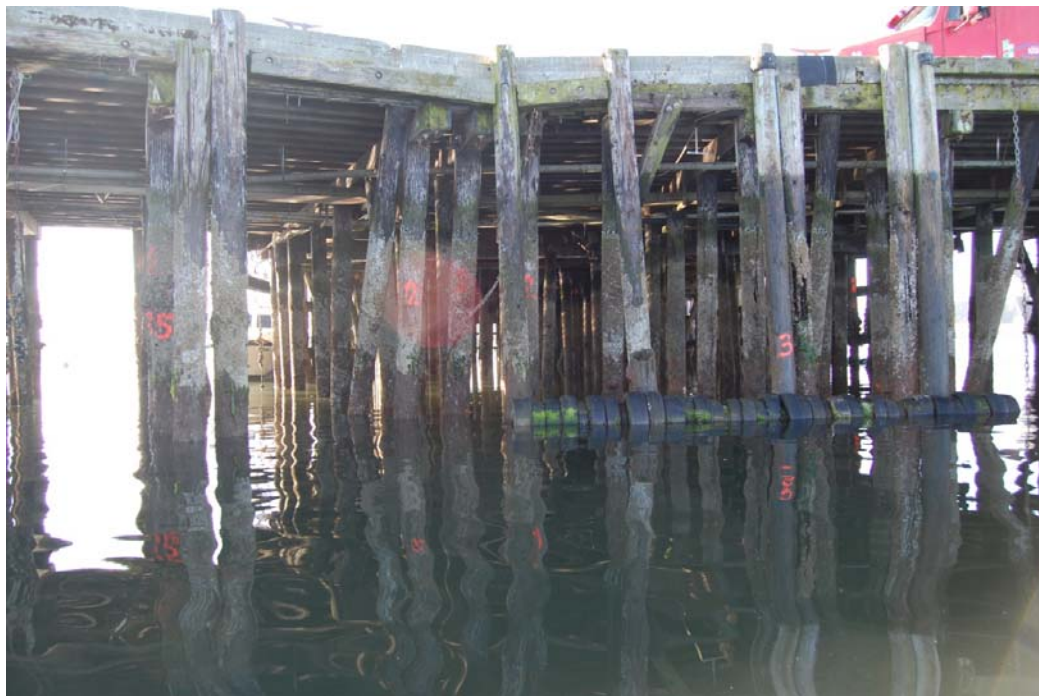
End of Approach Trestle (at left) and the start of the West Wharf (Photo #321)  
36"± vertical crack on pile at Bent 3 (shown behind fender pile painted "3")

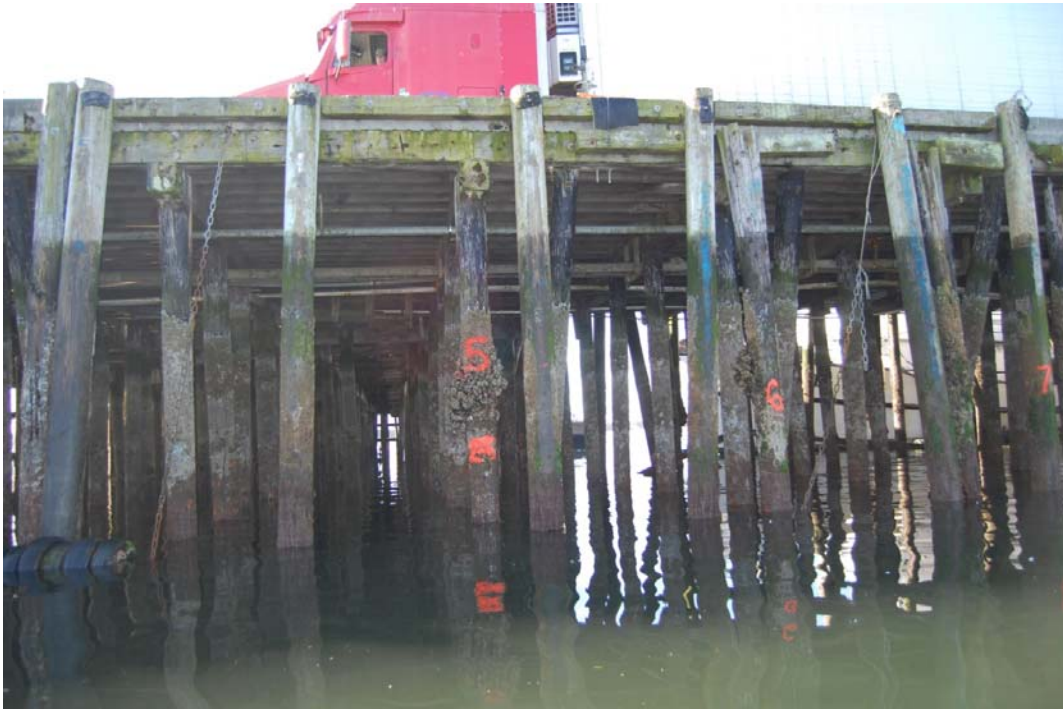
West Wharf Bents 4 to 7 (Photo #322)  
No damage noted

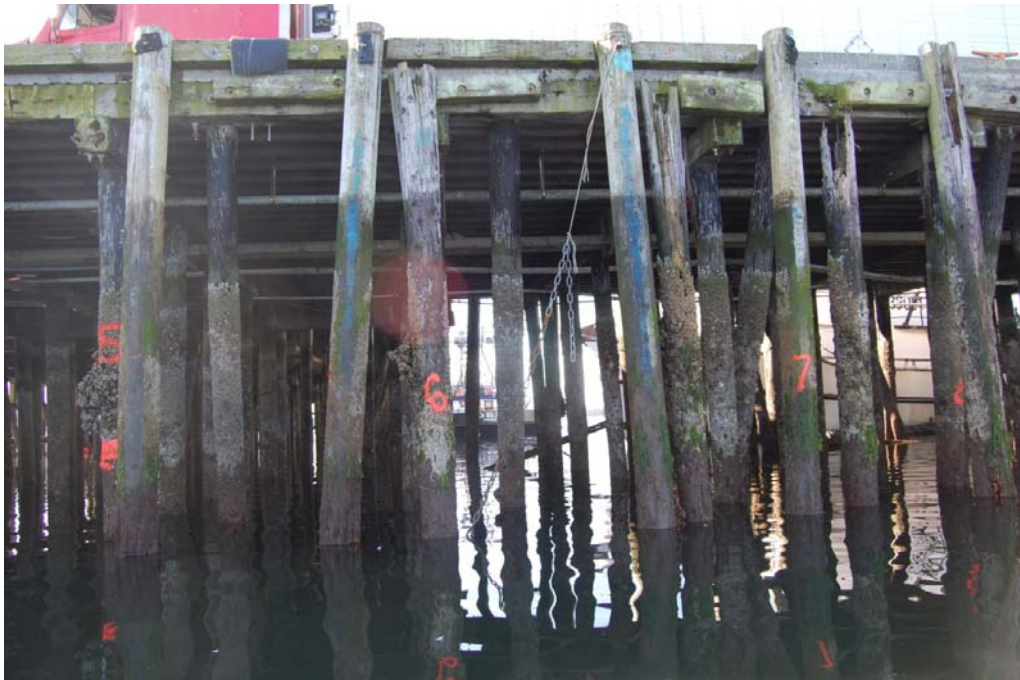
West Wharf Bents 5 to 8 (Photo #323)  
No damage noted

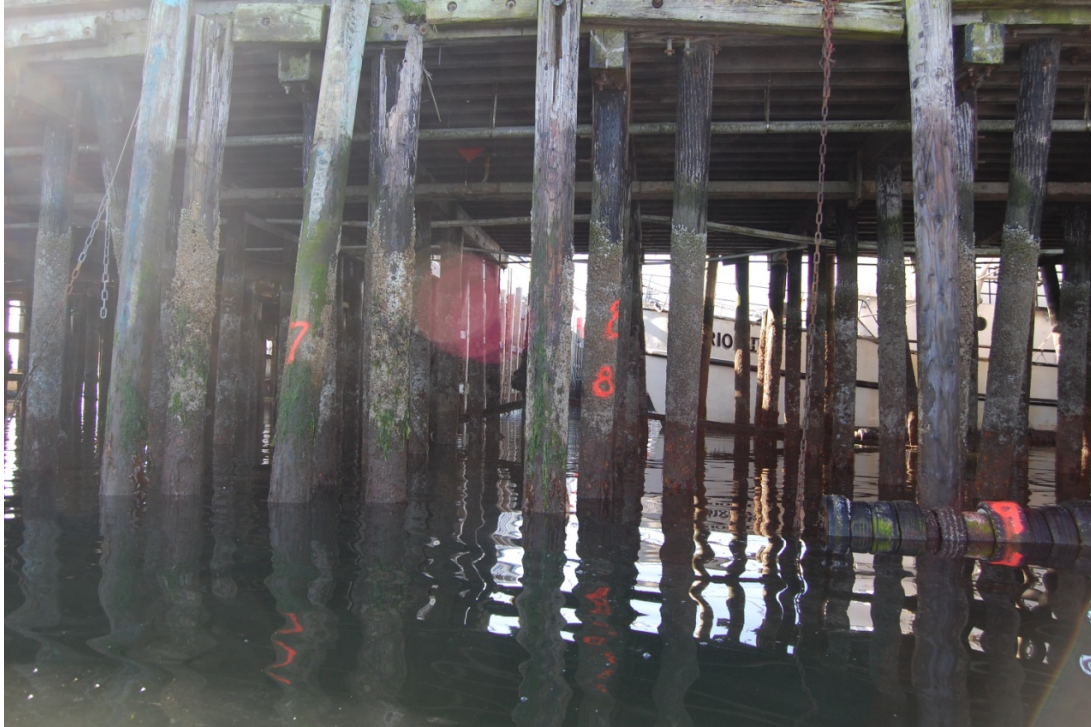
West Wharf Bents 6 to 9 (Photo #326)  
No damage noted

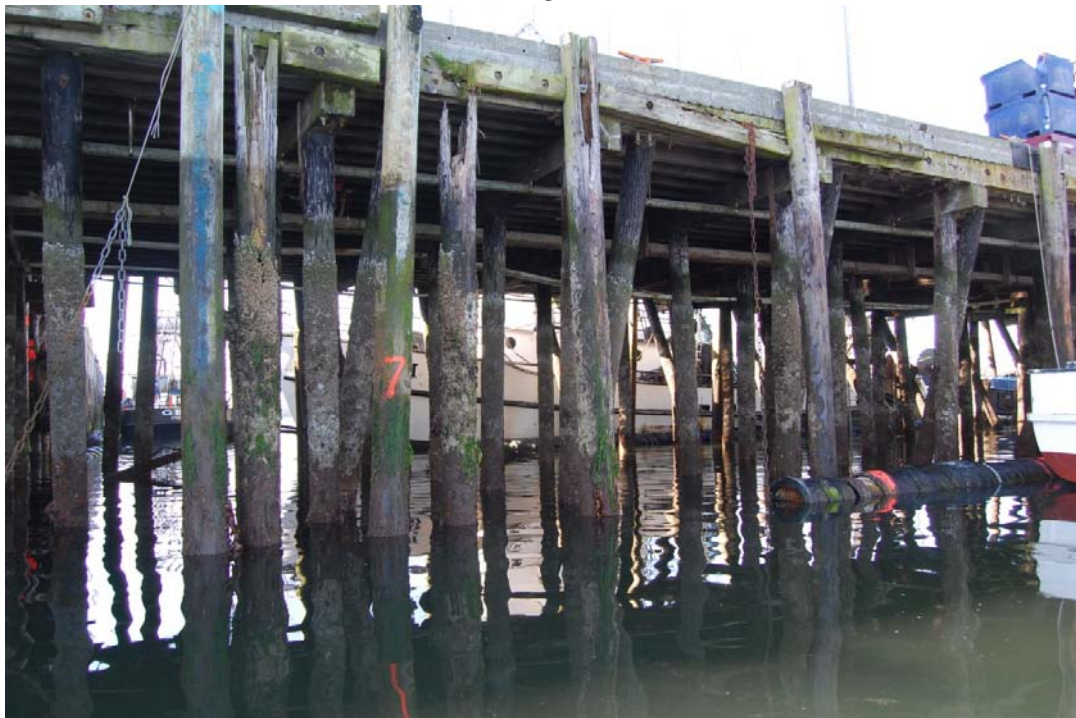
West Wharf Bents 7 to 10 (Photo #324)  
Repair/replace chock between Bents 8 & 9

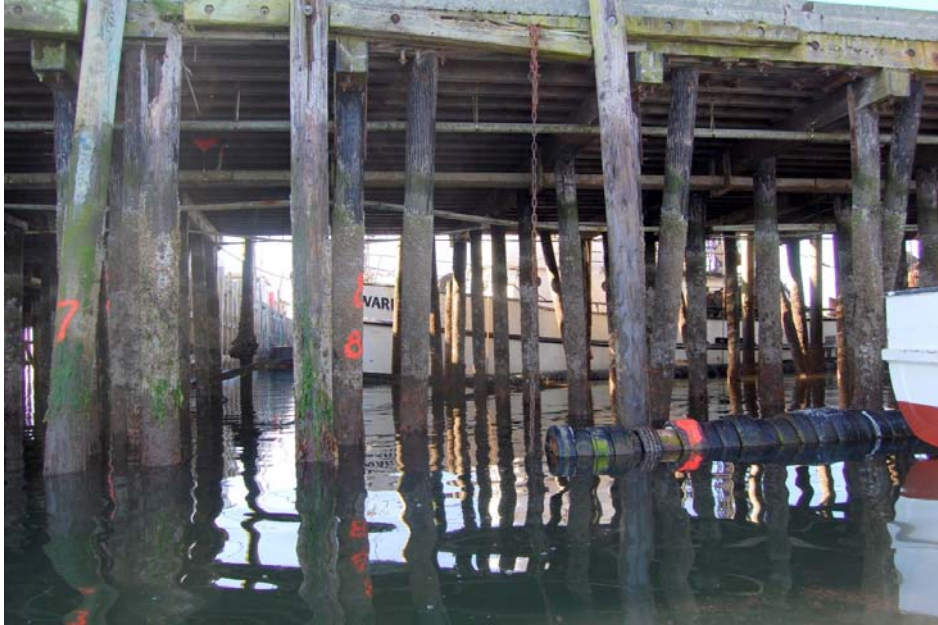
West Wharf Bents 7 to 10 (Photo #325)  
No damage noted

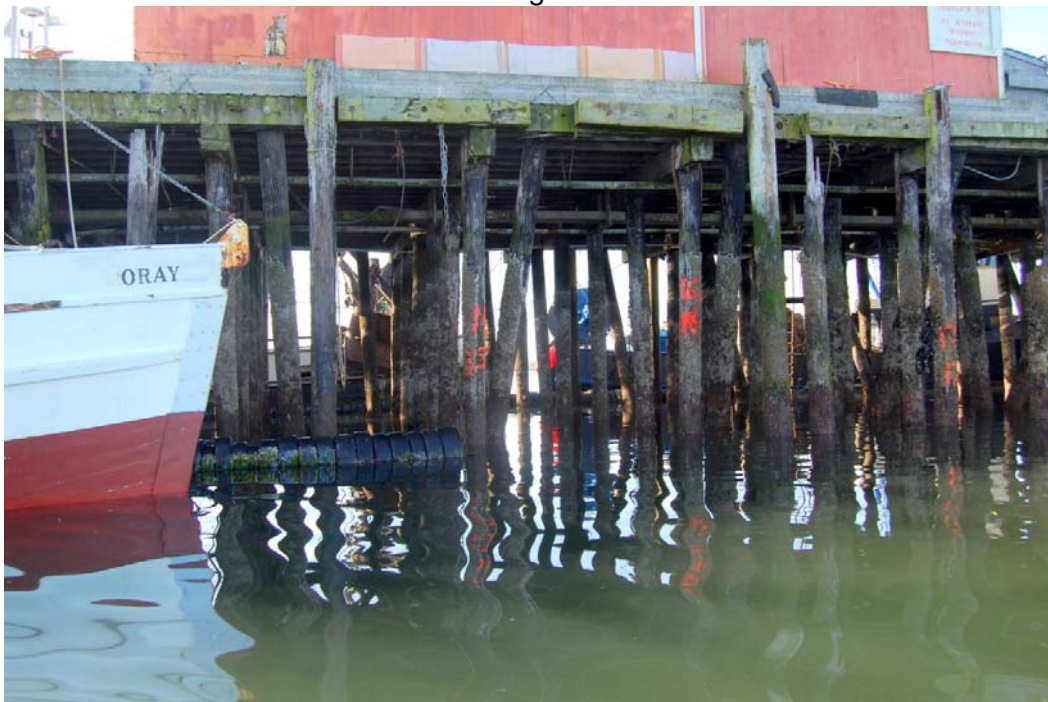
Between Bents 9 and 15 unable to survey due to the vessel "Moray" (Photo #327)  
Missing fender pile between Bents 15 & 16

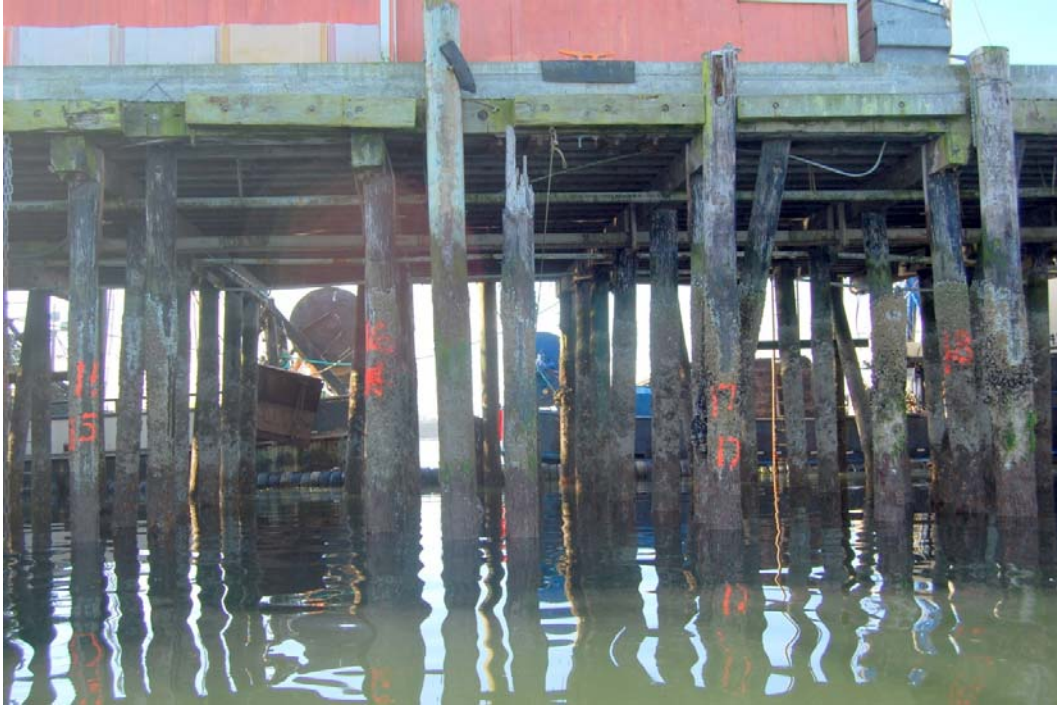
West Wharf Bents 15 to 18 (Photo #329)  
No damage noted, except missing fender pile between Bents 15 & 16

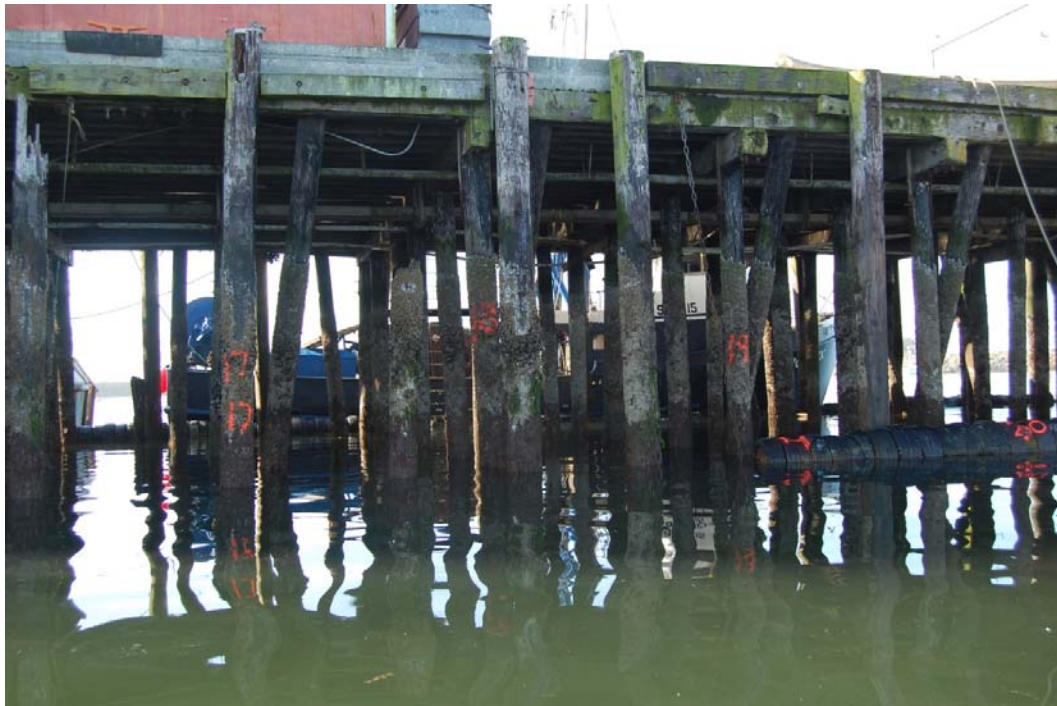
West Wharf Bents 17 to 20 (Photo # 330)  
No damage noted. Replace missing chock between bents 18 & 19

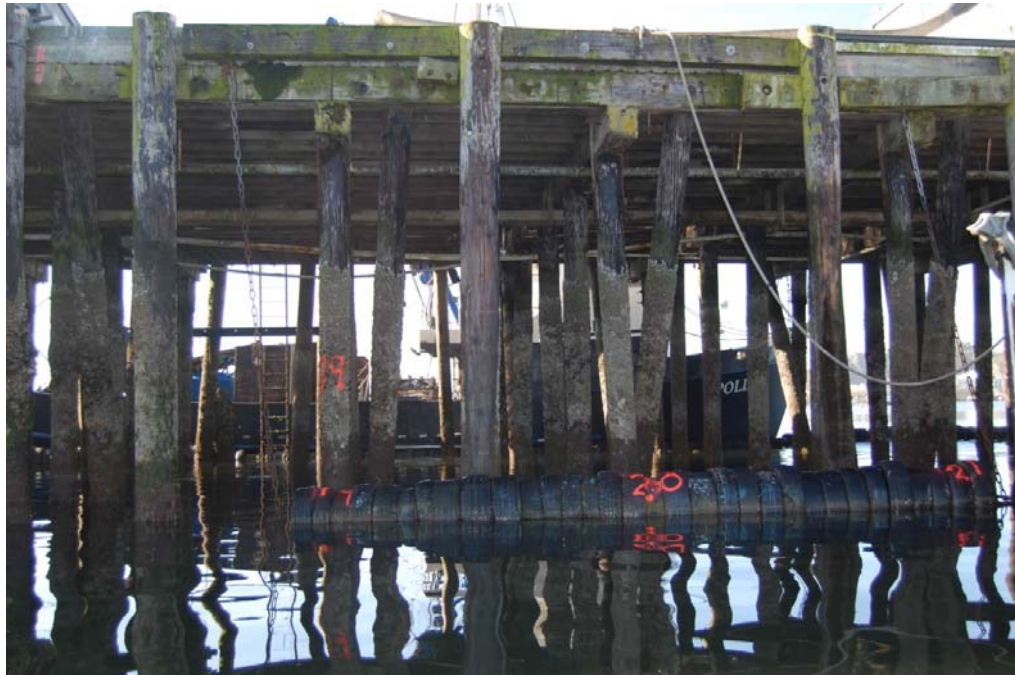
West Wharf Bents 19 to 21 (Photo #331)  
No damage noted. Replace missing chocks between Bents 18 & 21

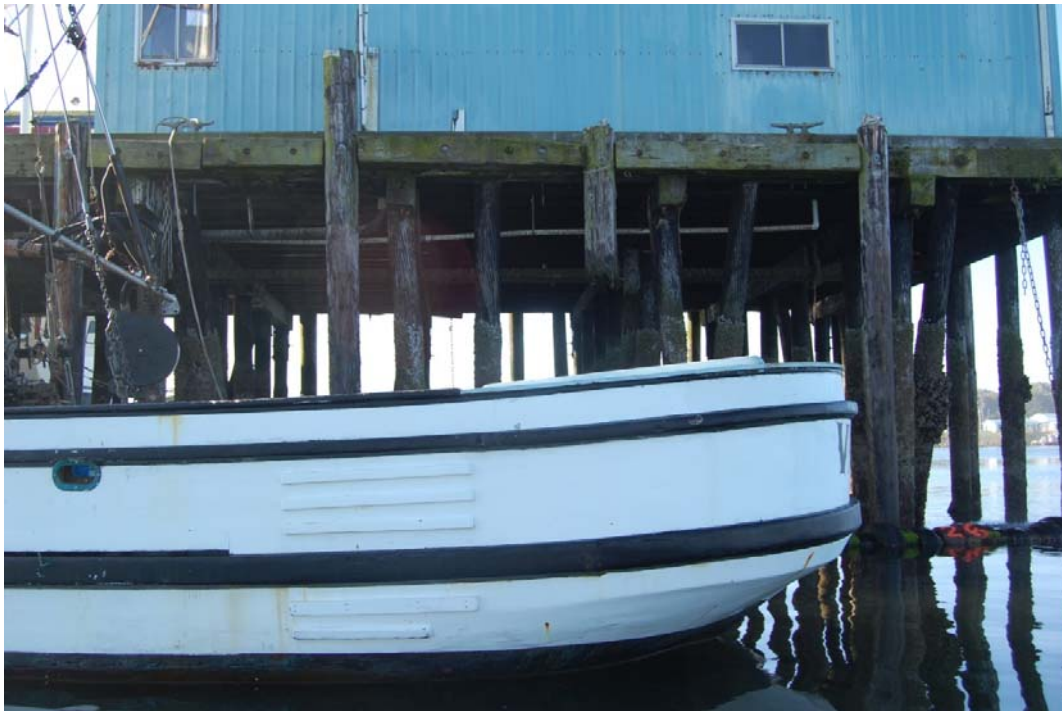
Between Bents 18 and 25 unable to survey due to the vessel "Victory" (Photo #332)  
Lower portion of fender pile between Bents 24 & 25 is broken off

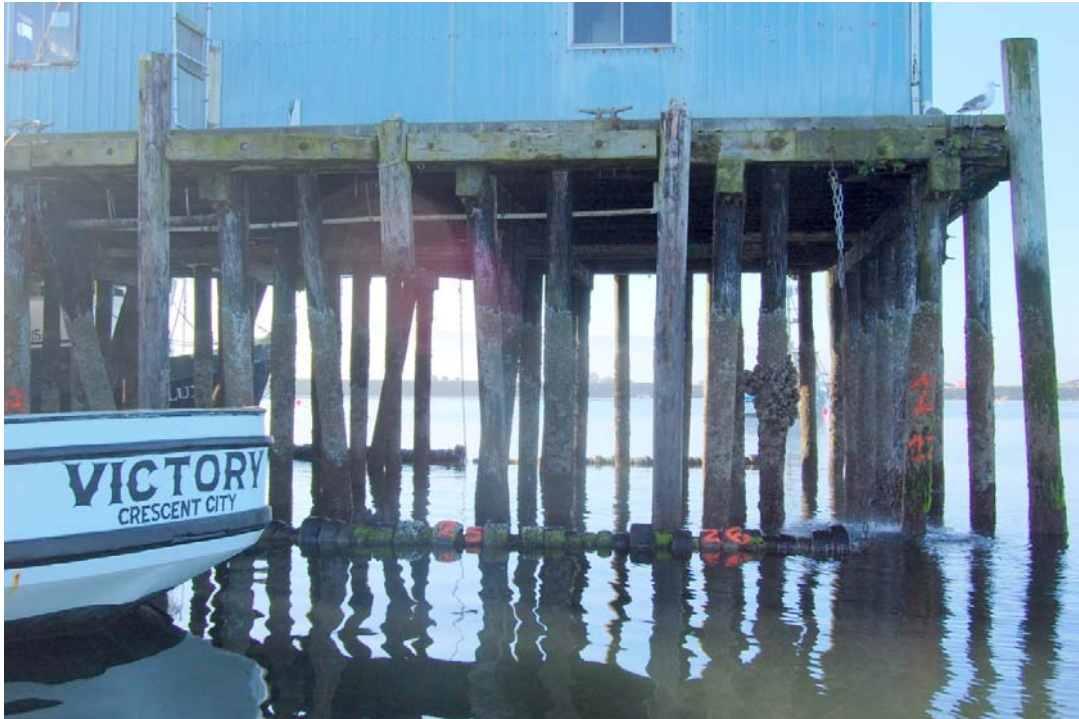
Bents 24 to 27 (Photo #333)  
Replace broken fender pile between Bents 24 & 25  
Add chocks between Bents 26 & 27

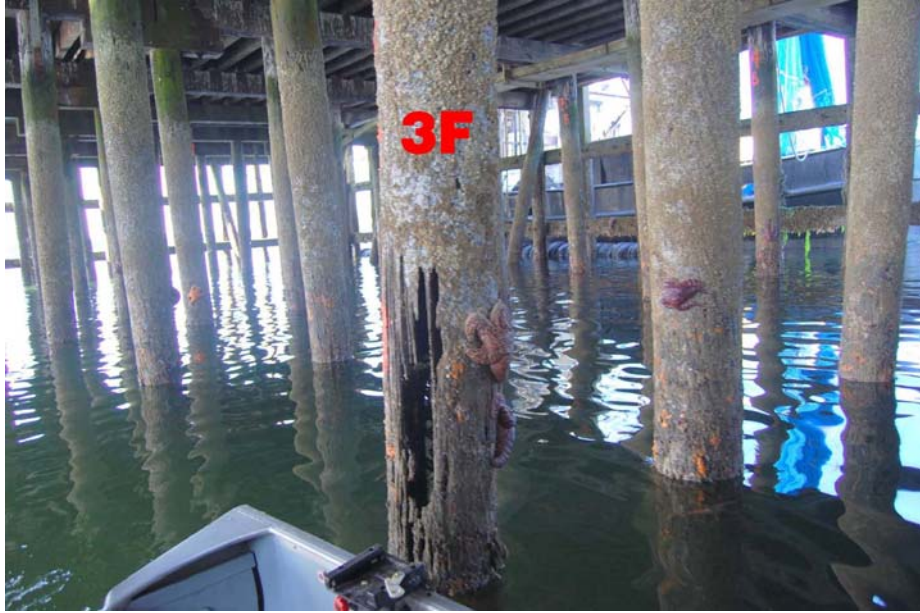
Pile 3F (Photo #365)

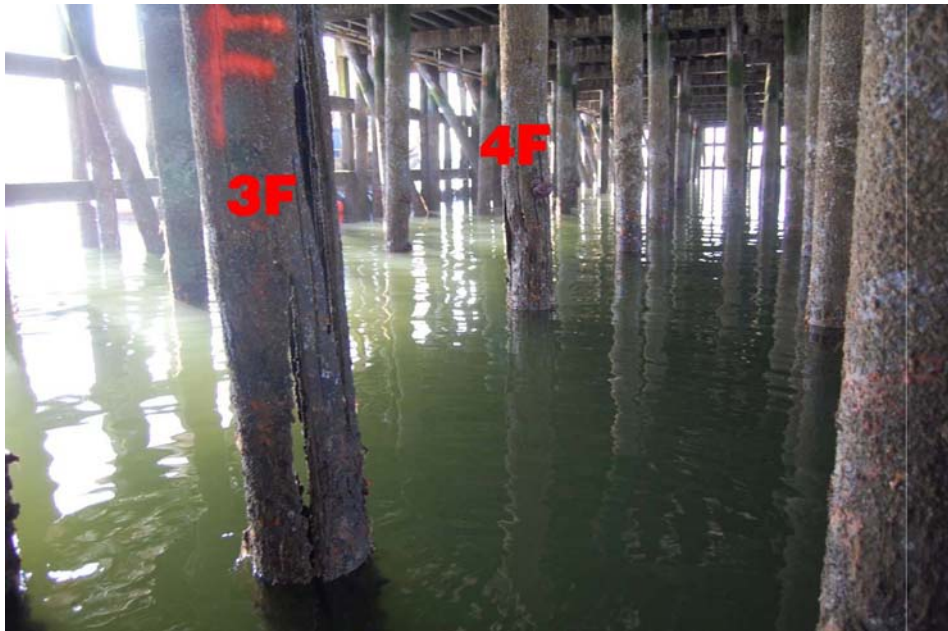
Pile 4F (Photo #354)
