**Ben C. Gerwick, Inc.**  
Member of the COWI Group

Consulting Engineers  
1300 Clay Street, 7th Floor  
Oakland, CA 94612  
Tel. 510.839.8972  
Fax. 510.839.9715  
<http://www.gerwick.com/>

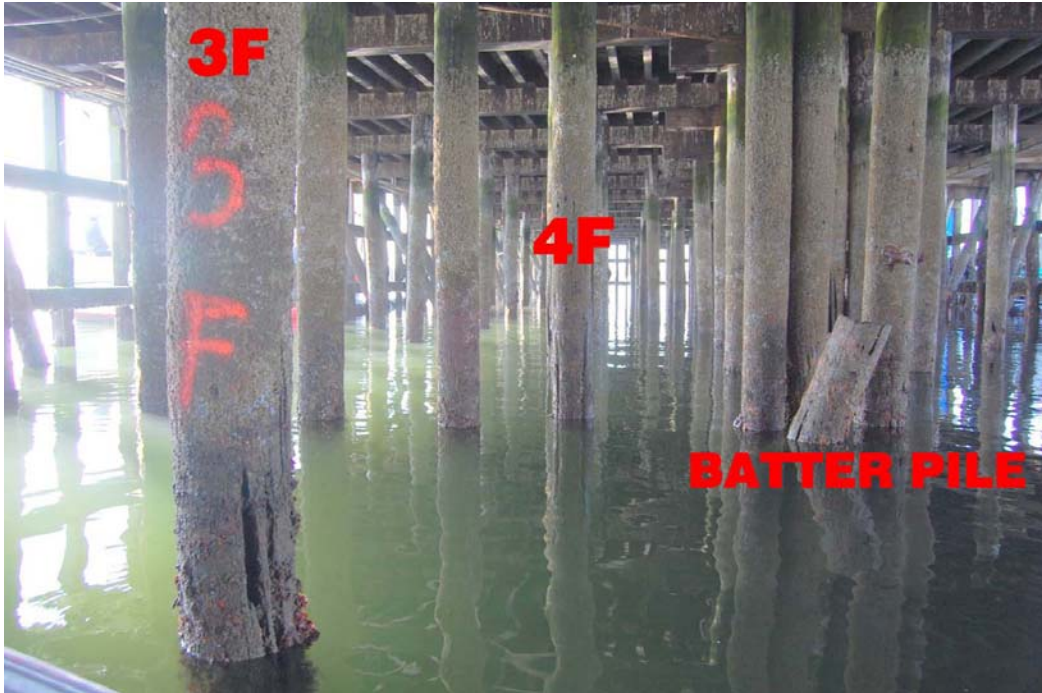
Piles 3F, 4F and batter pile (Photo #353)

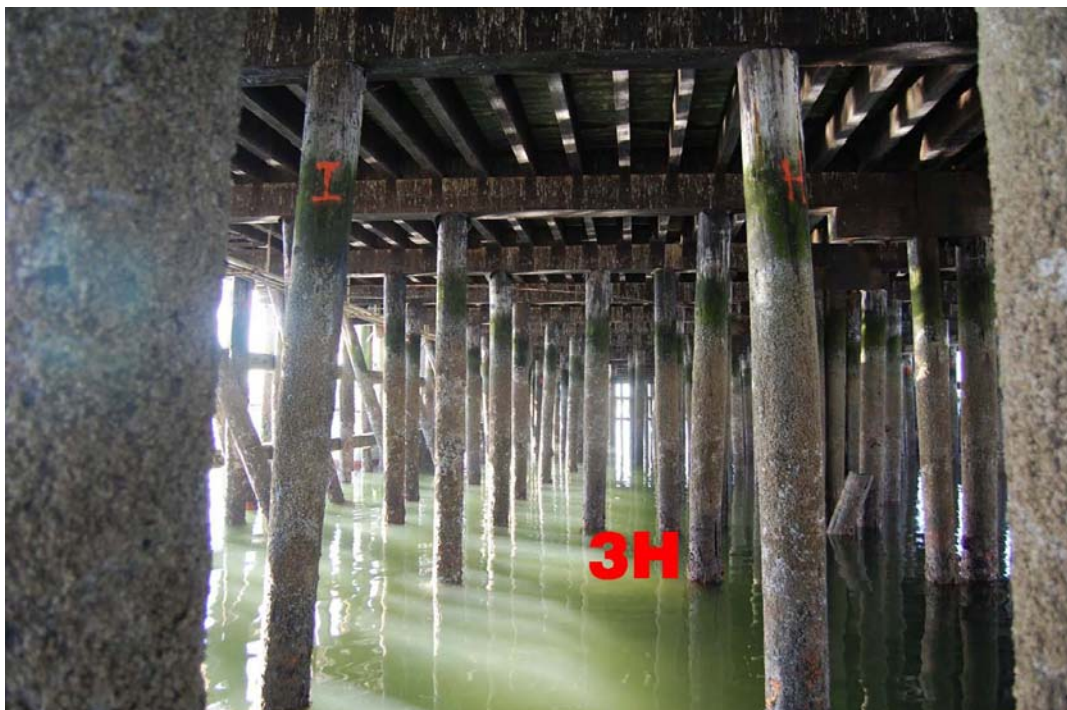
Pile 3H (Photo #348)

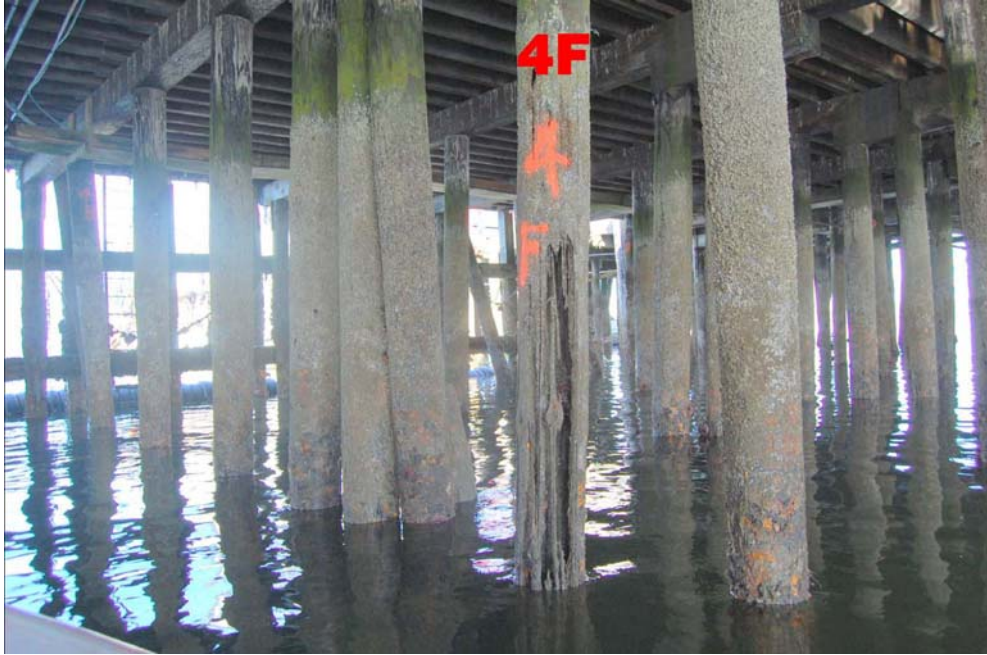
Pile 4F (Photo #371)

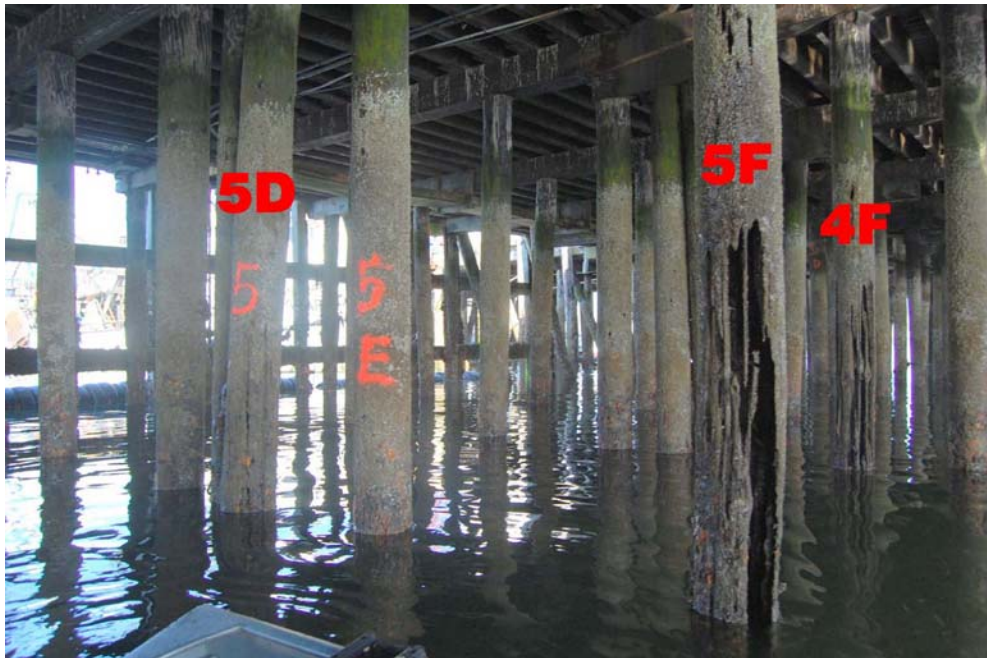
Piles 5D, 5F, and 4F (Photo #357)

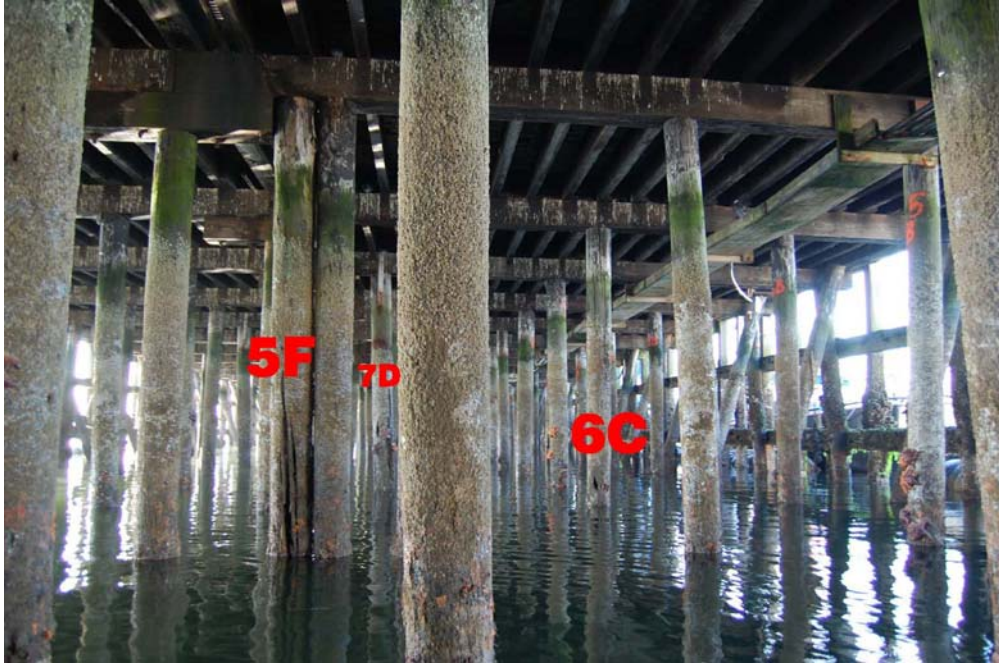
Piles 5F, 6C, and 7D (Photo #355)

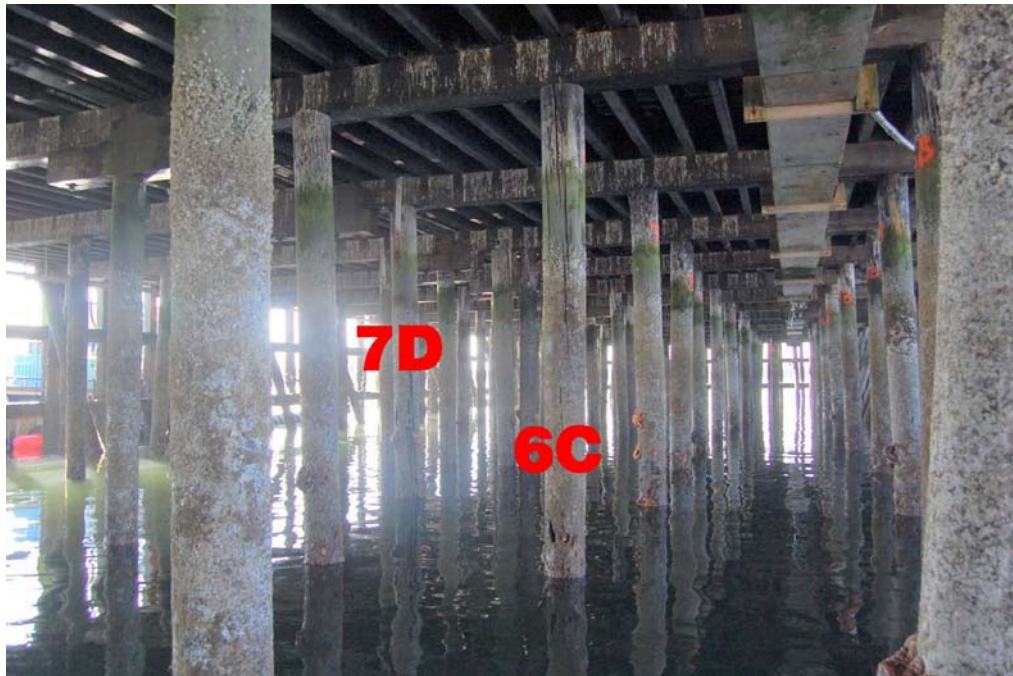
Pile 6C (Pile 7D beyond)

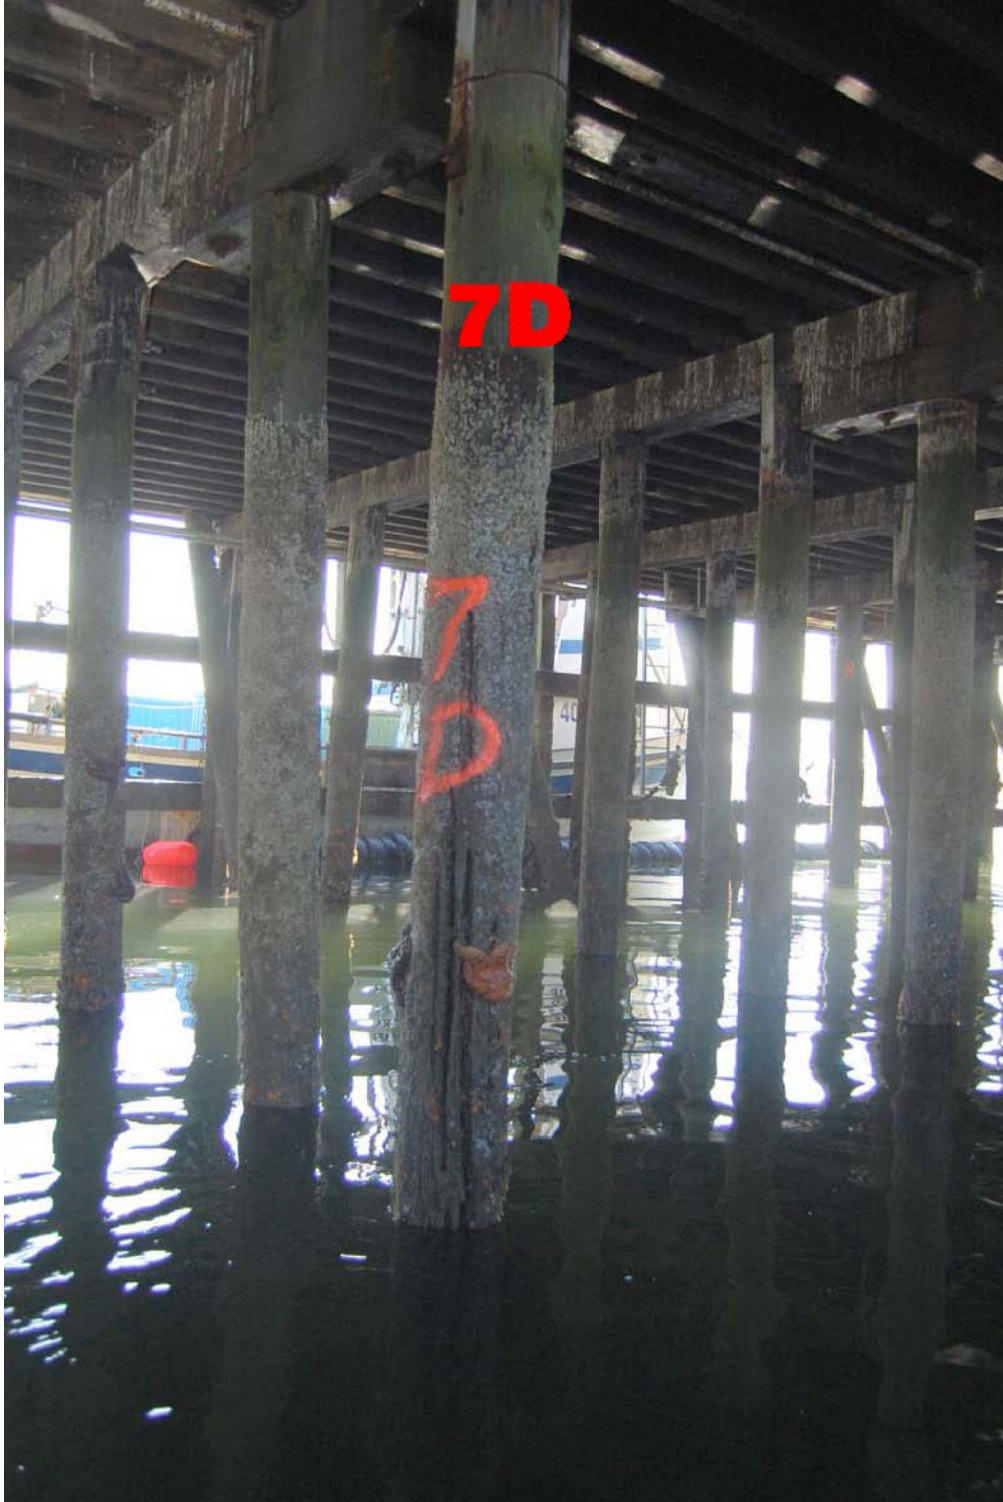
Pile 7D (Photo #360)

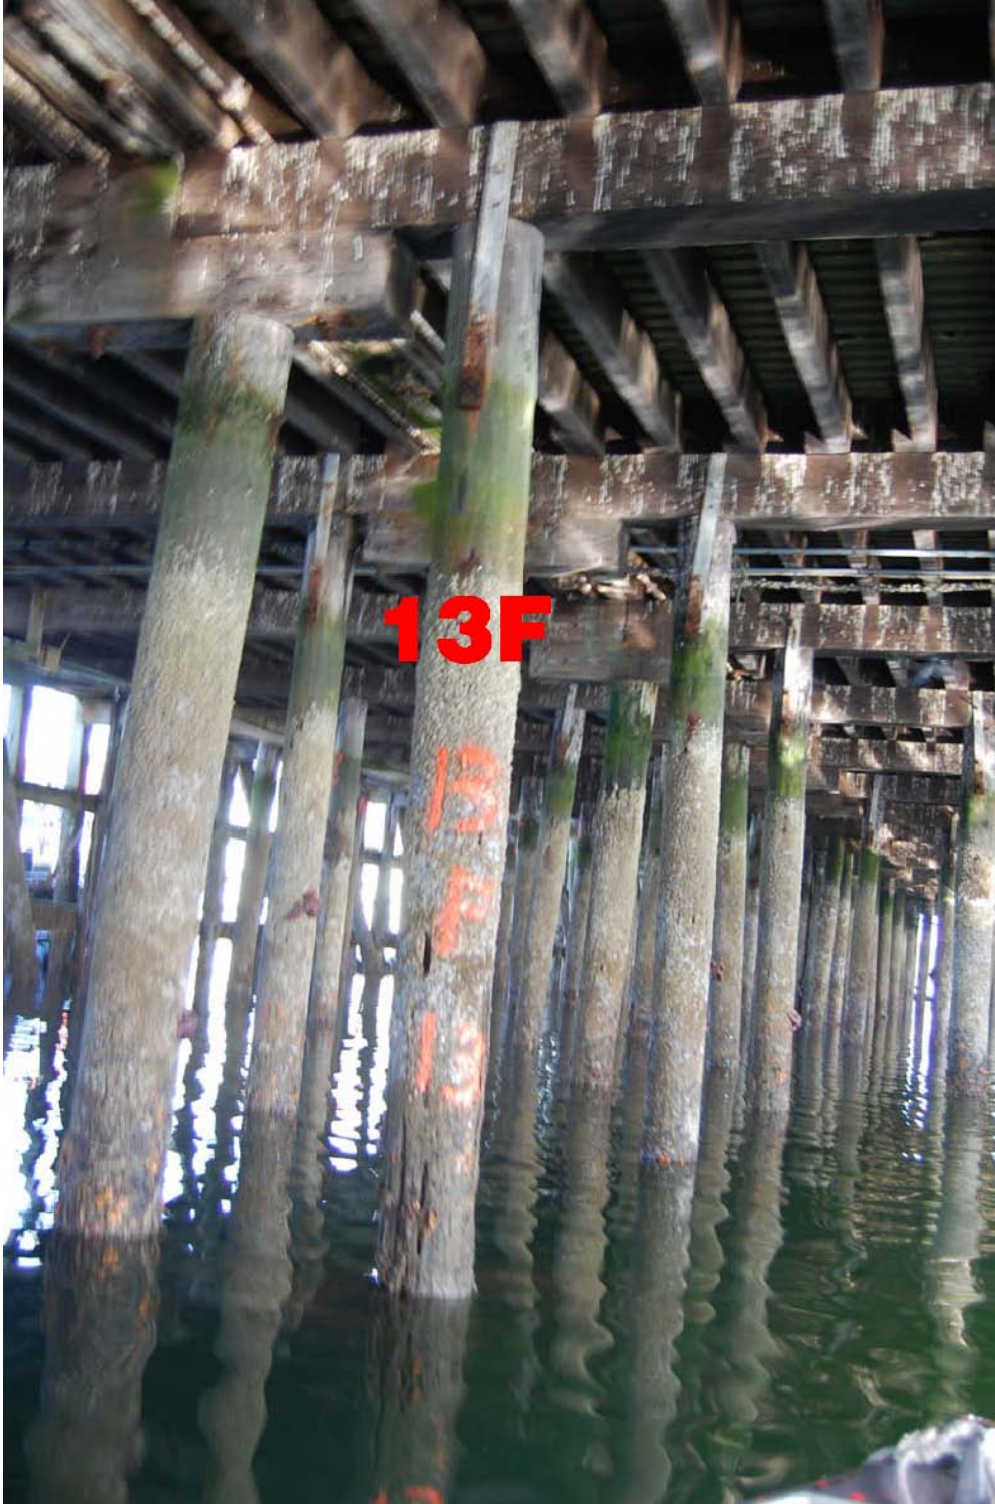
Pile 13F (Photo #364)

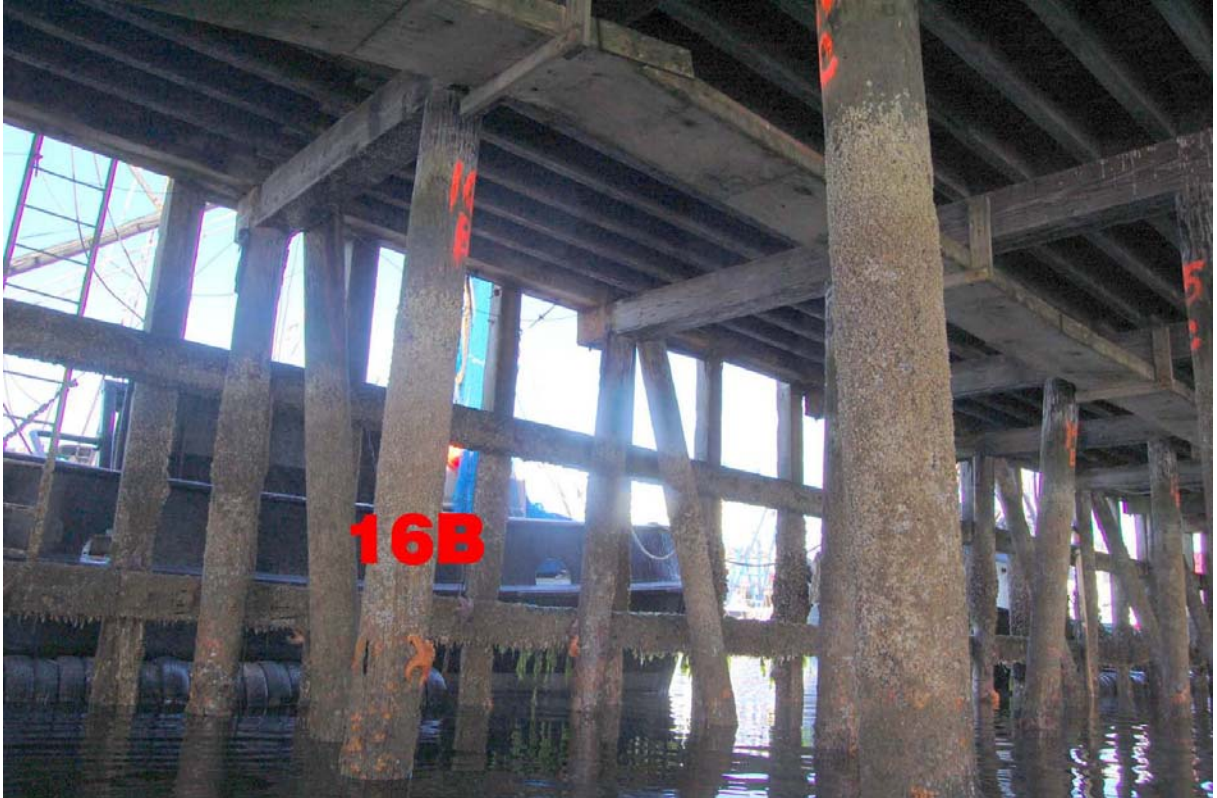
Pile 16B (Photo #362)

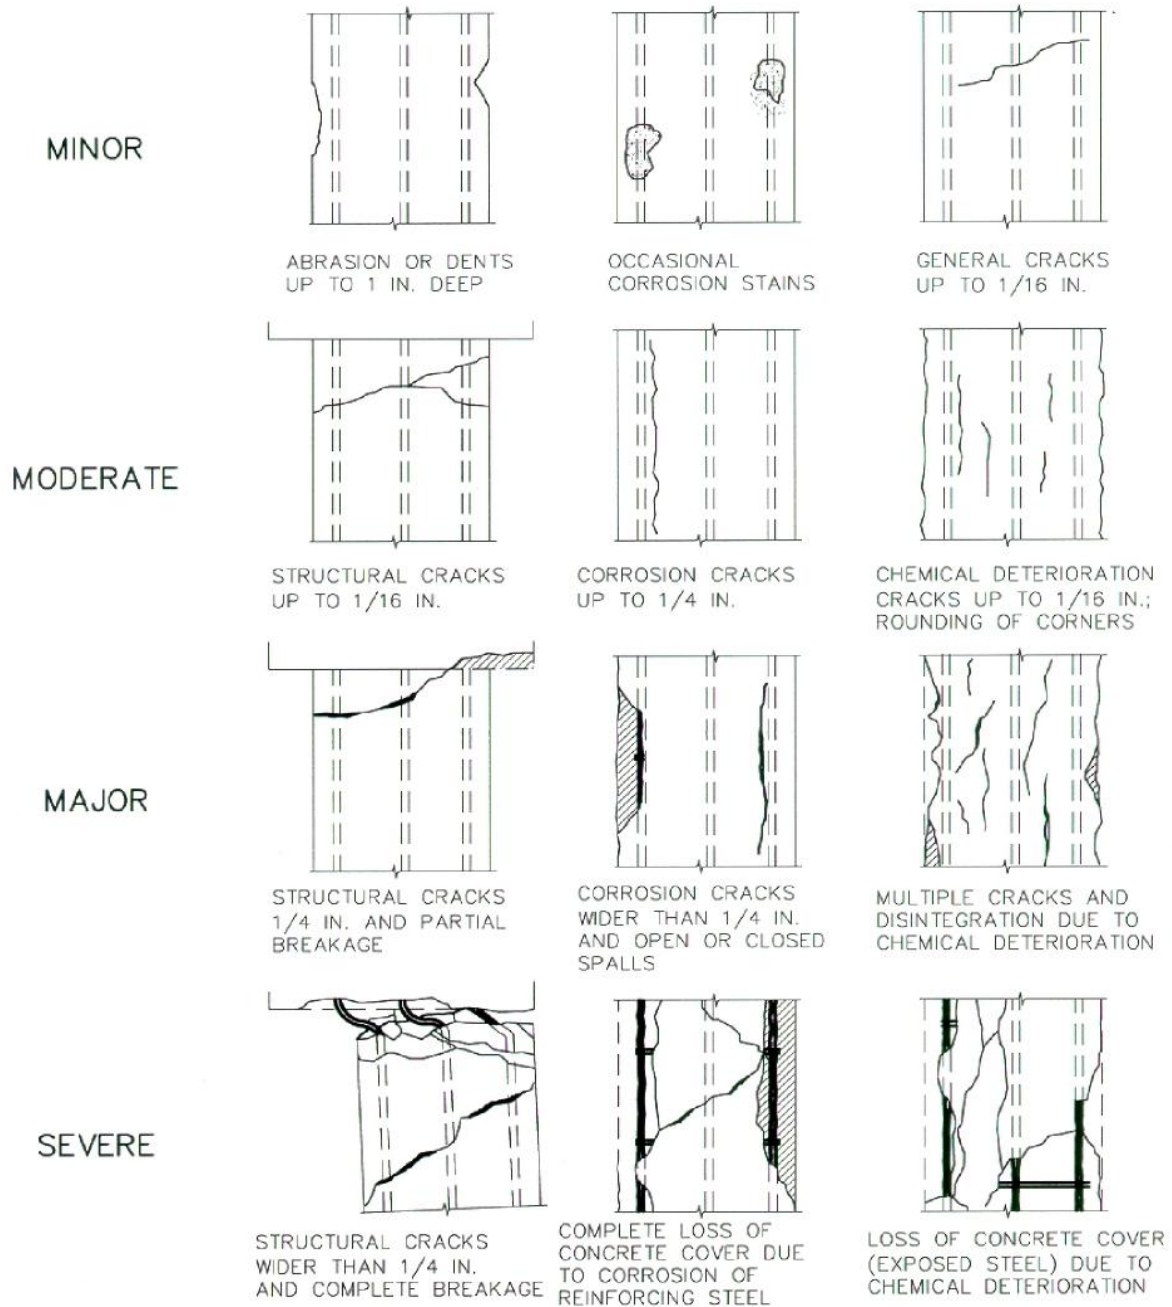
**TABLE 2-3  
CONDITION ASSESSMENT RATINGS FOR PRESTRESSED CONCRETE ELEMENTS**

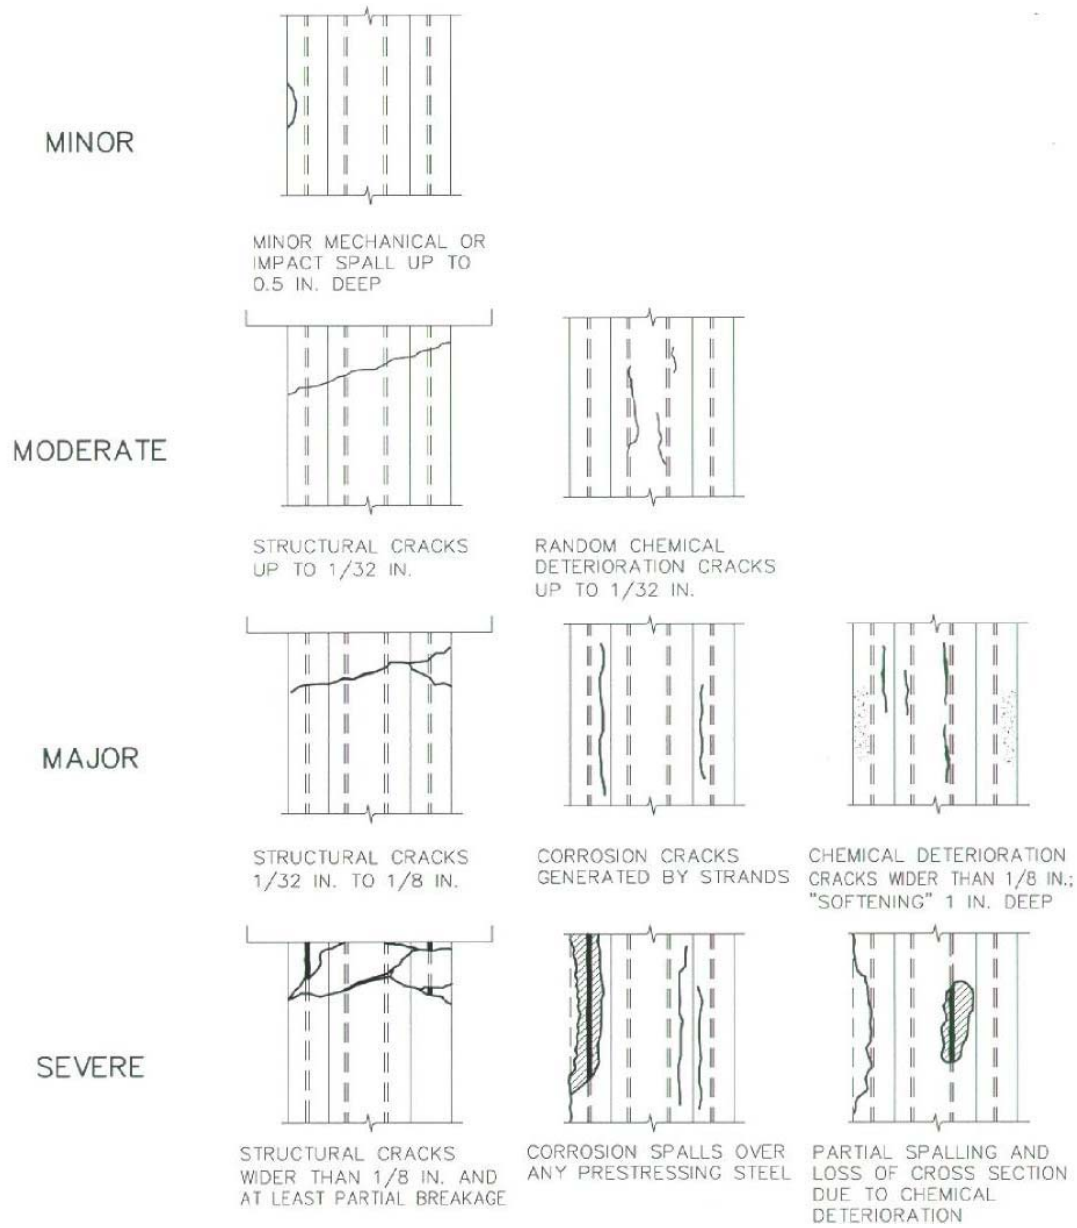
**TABLE 2-4  
CONDITION ASSESSMENT RATING OF TIMBER ELEMENTS**

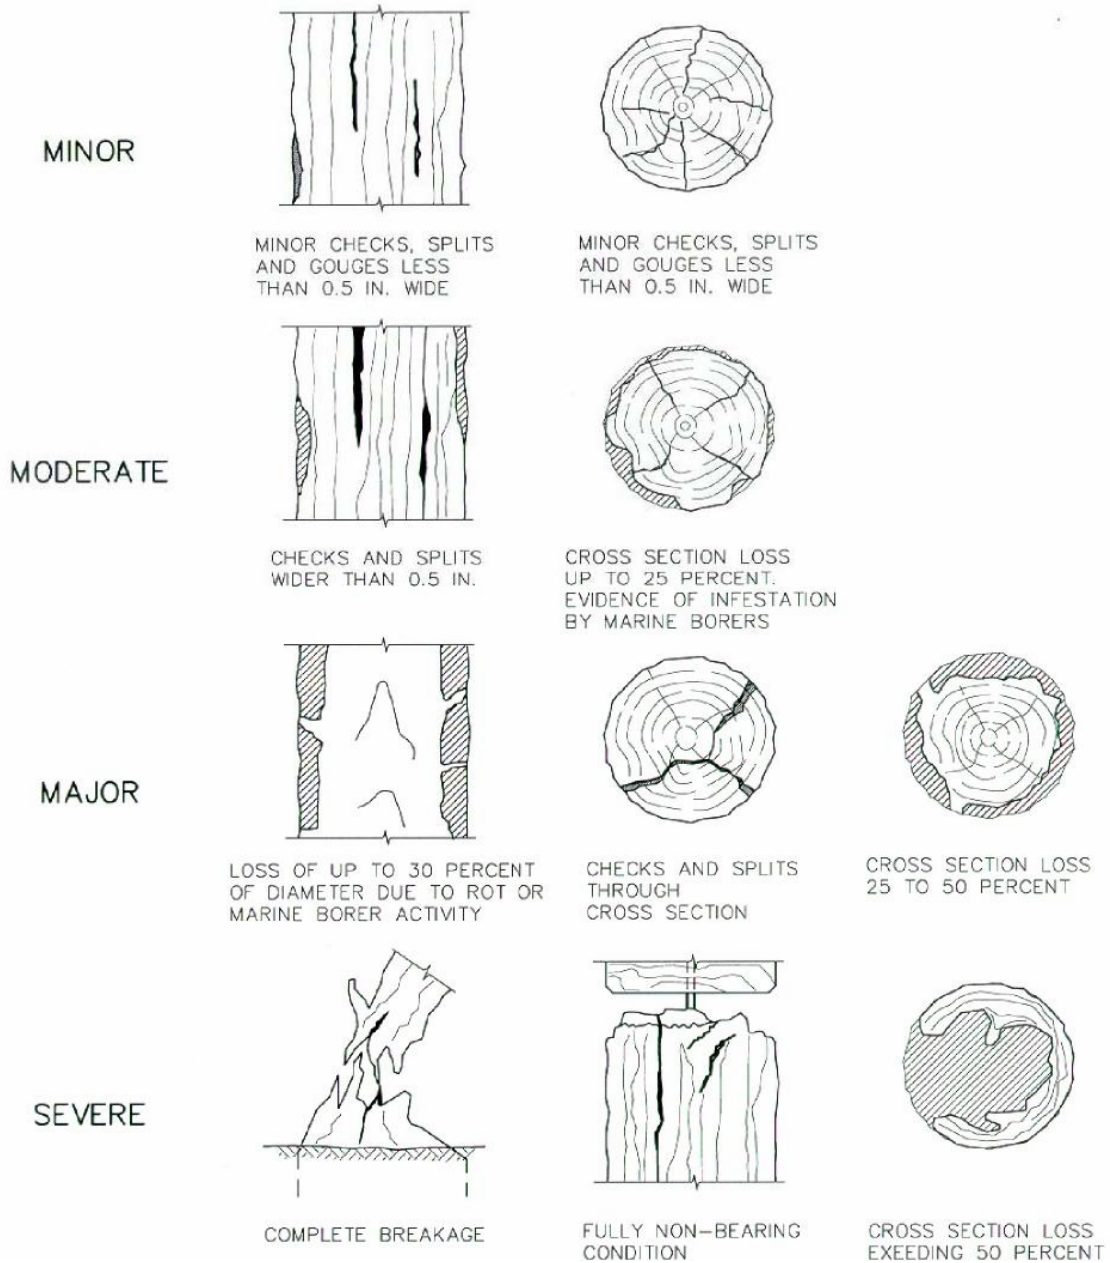
# Appendix D      Citizens Dock Repair Cost Estimate
