SEAWALL CONDITION ASSESSMENT REPORT

Crescent City, CA

Client	Crescent City Harbor District
Project name	CCHD Seawall Condition Assessment
Document title	Seawall Condition Assessment Report
Status	Final
Date	17 April 2023
Project number	220548

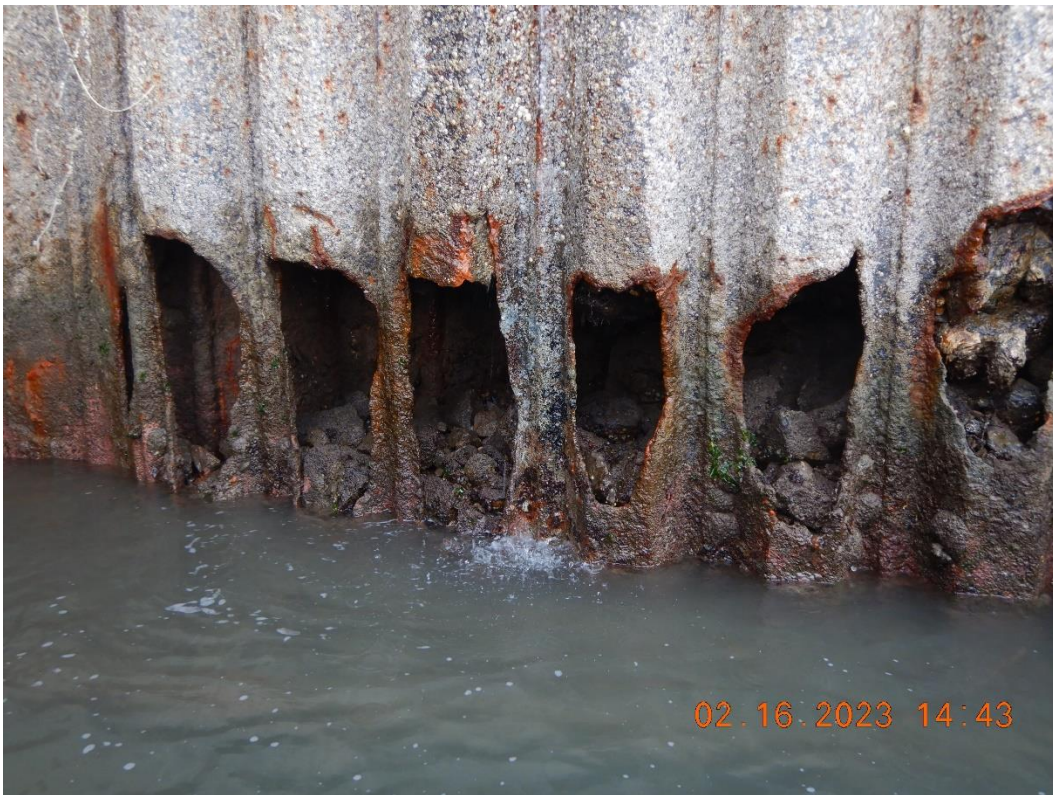
The steel sheet piles have major and severe levels of corrosion, section loss, and holes throughout. The sheets from STA 0+00 to 1+00 have the most significant amount of corrosion near the mean lower low water (MLLW) level and also appear to have buckled above the corrosion holes. Large voids in the backfill were observed from STA 0+00 to 1+00.

Photo 2. Severe corrosion holes from STA 0+00 to 1+00

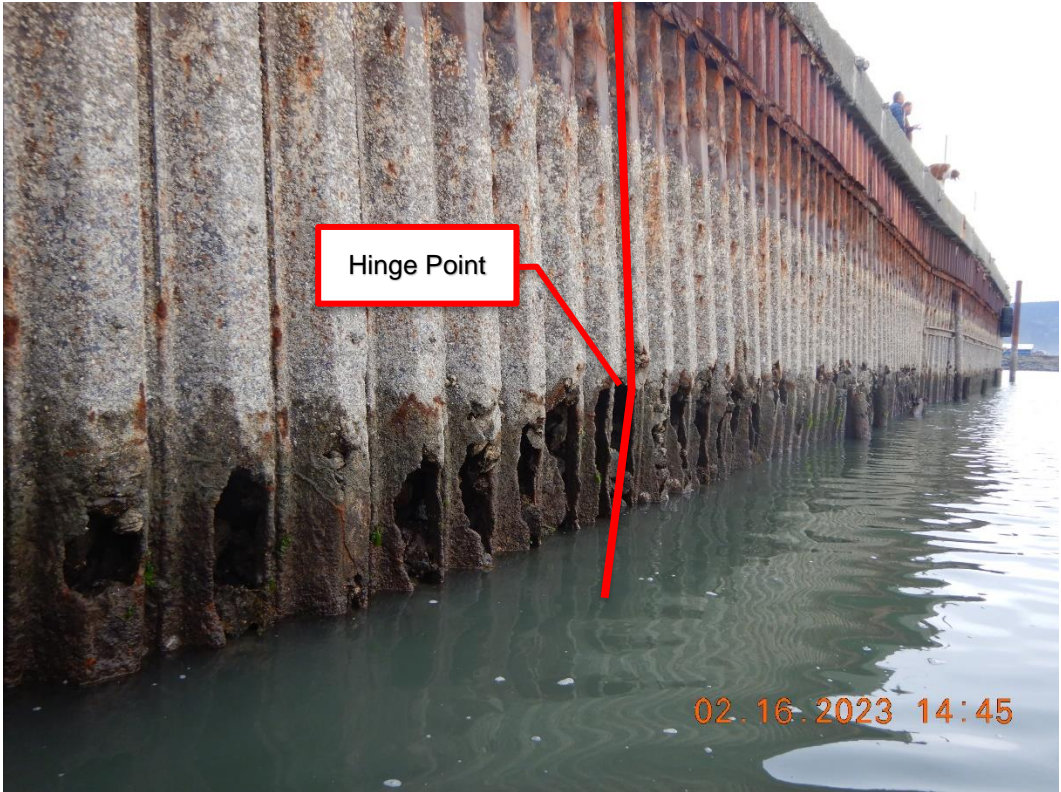
Photo 3. Buckling of bulkhead from STA 0+00 to 1+00

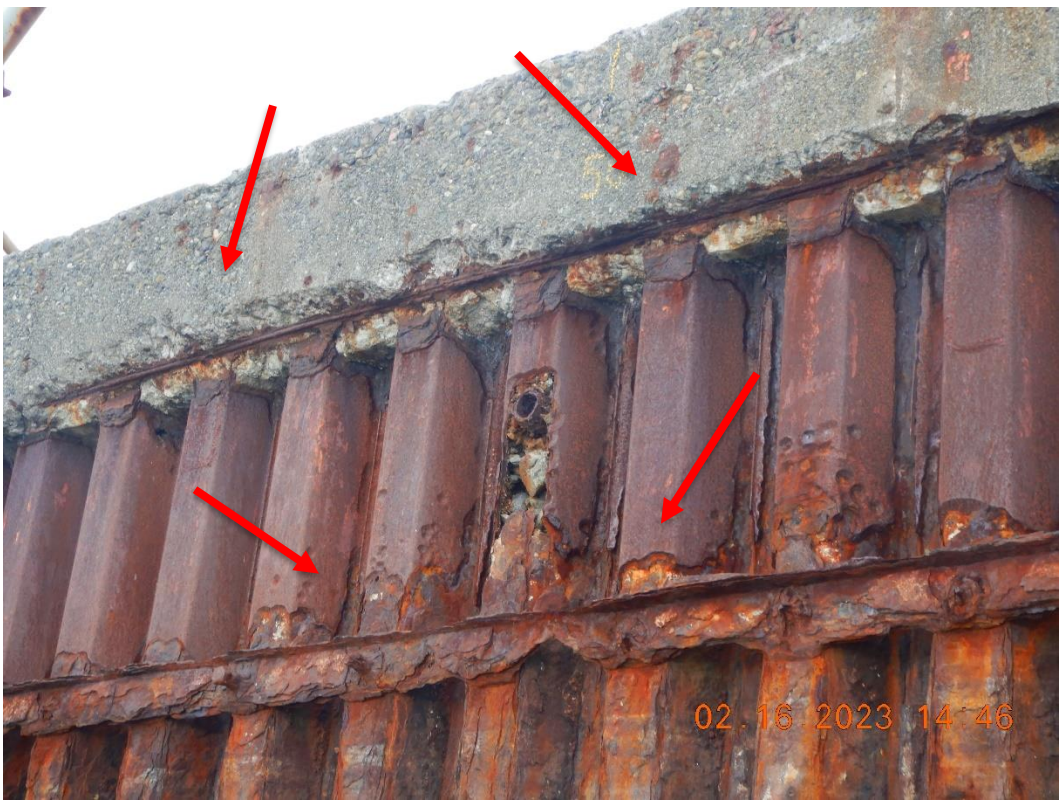
The concrete cap has moderate to severe damage, including open corrosion spalls with exposed and corroding reinforcement. Vertical and shear cracks were observed at multiple locations.

Photo 4. Typical major concrete cap spalling; typical severe upper water corrosion from STA 0+00 to 2+00

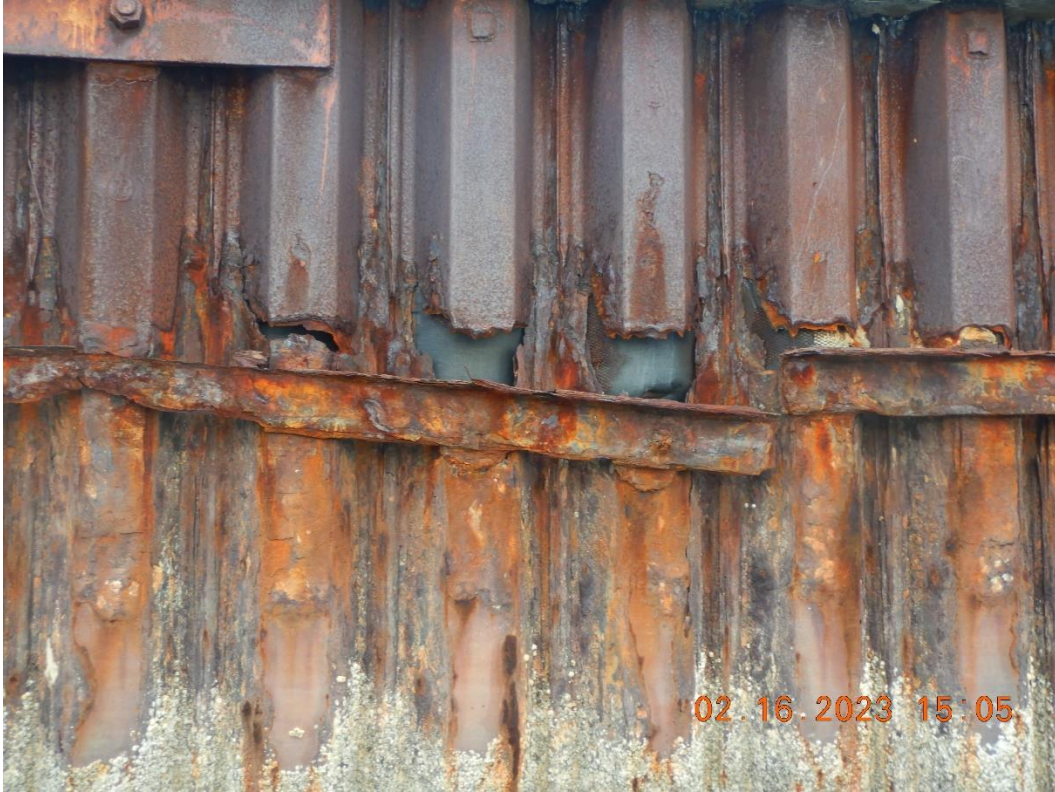
The upper waler has major to severe levels of corrosion and section loss throughout its length. The waler has up to 100% section loss at several locations. The tie-rod hardware has severe corrosion and up to 100% section loss.

Photo 5. Severe corrosion of upper waler at STA 1+60

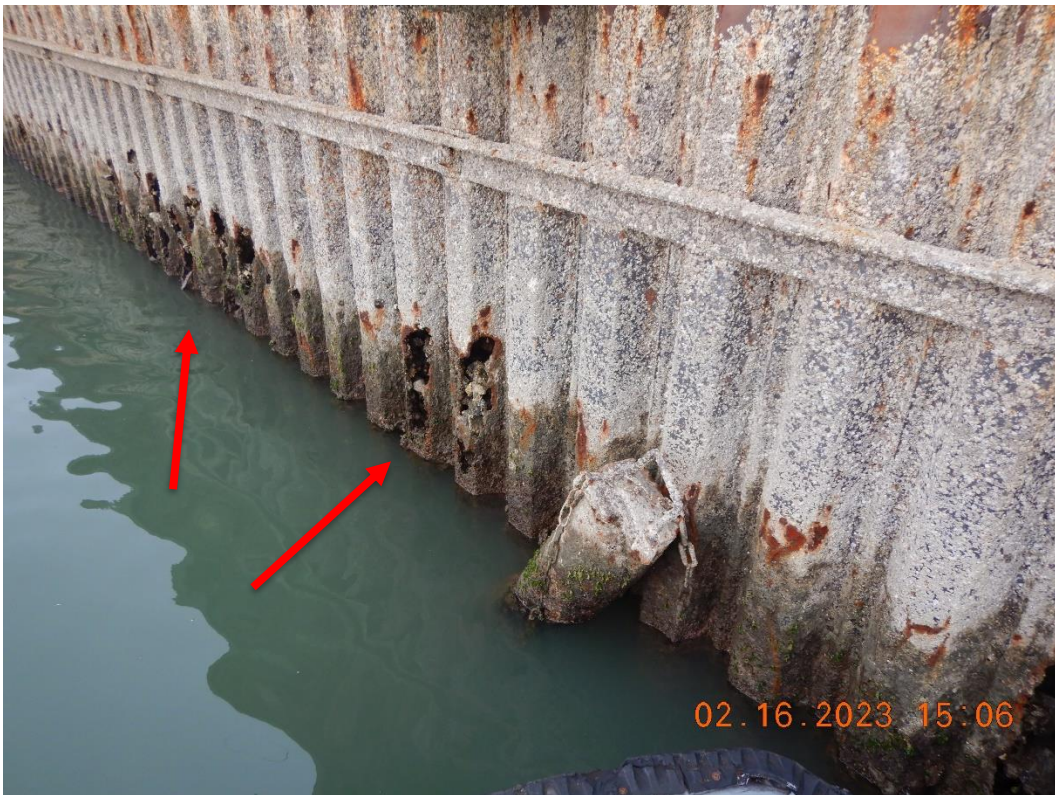
Photo 6. Typical severe corrosion holes and lower waler from STA 1+00 to 2+00

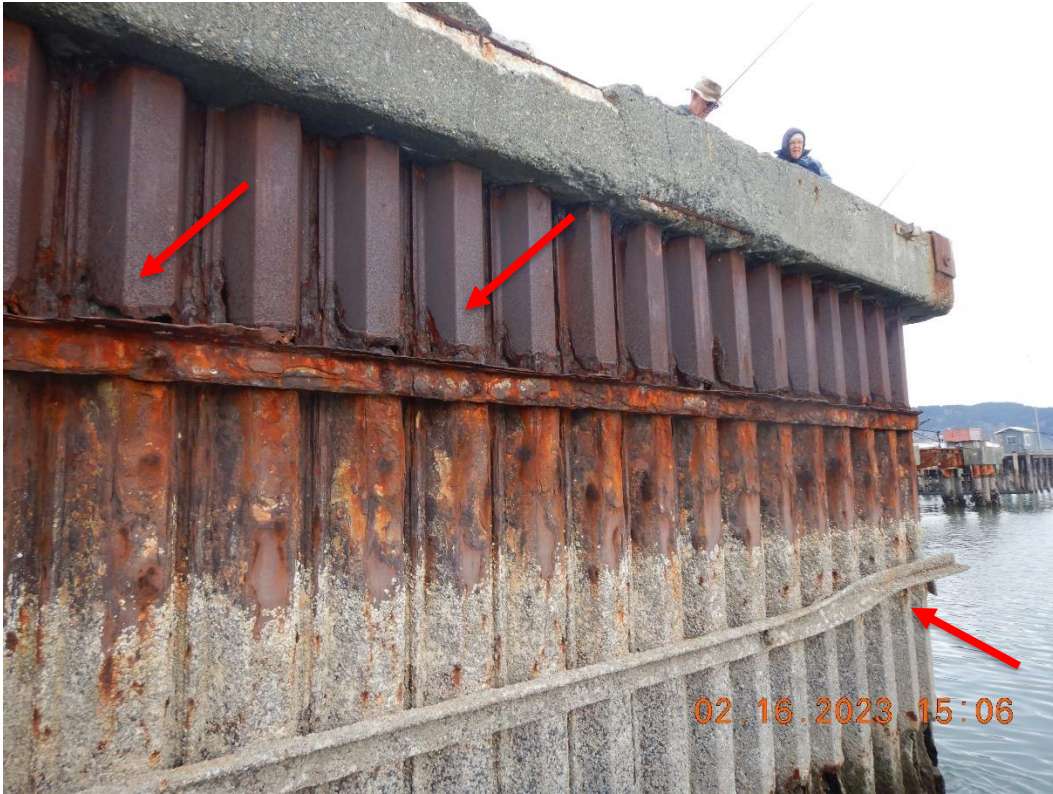
The lower waler has minor corrosion and section loss throughout its length. At STA 2+00 the lower waler is disconnected from the bulkhead.

Photo 7. Bent and disconnected lower waler at STA 2+00; typical severe corrosion above upper waler from STA 1+00 to 2+00

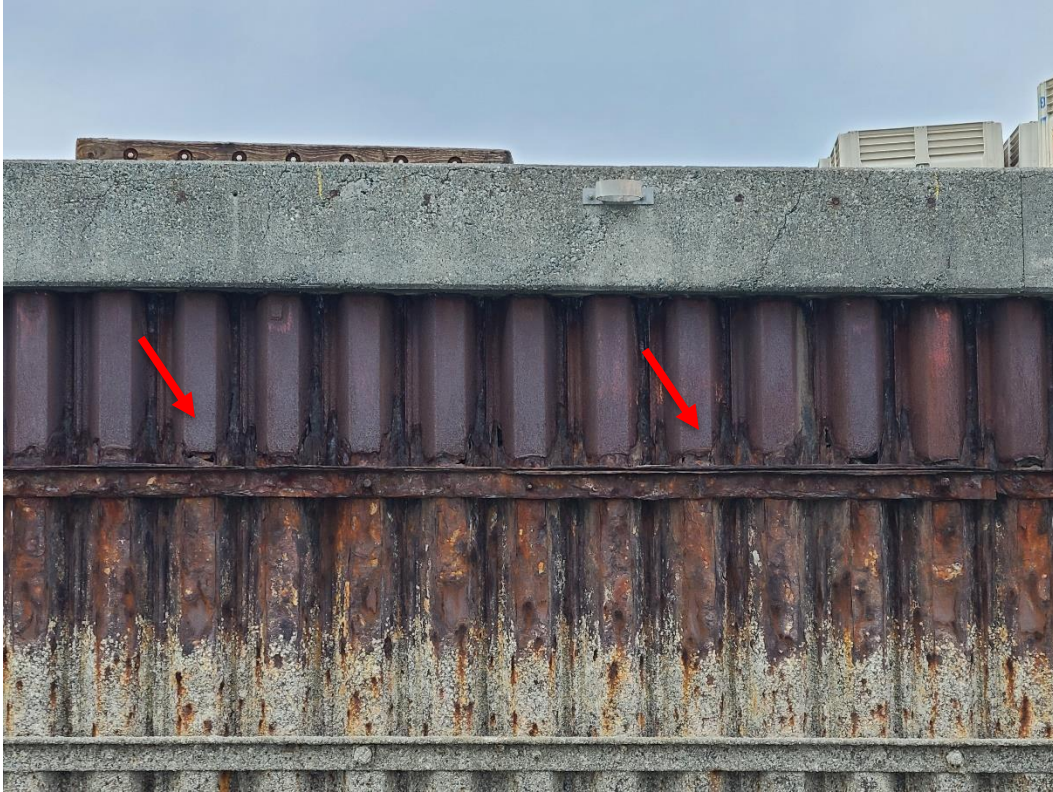
Photo 9. Typical severe corrosion above upper waler from STA 2+00 to 3+00

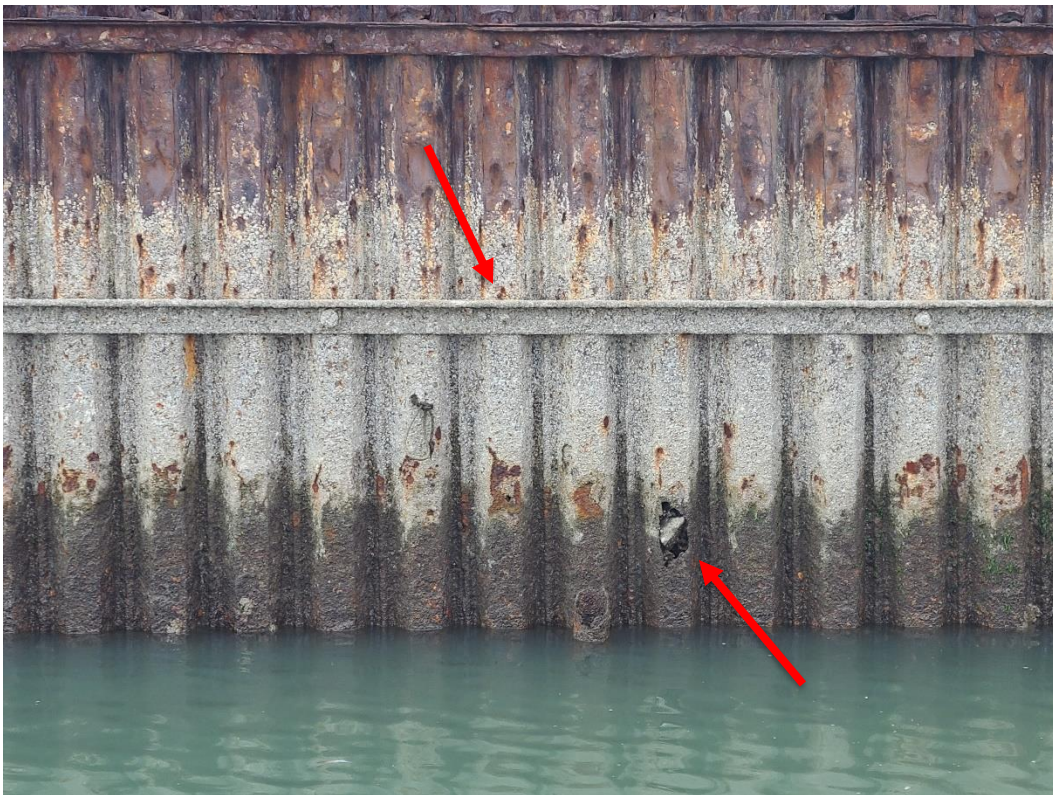
Photo 10. Typical corrosion holes and lower waler from STA 2+00 to 3+00

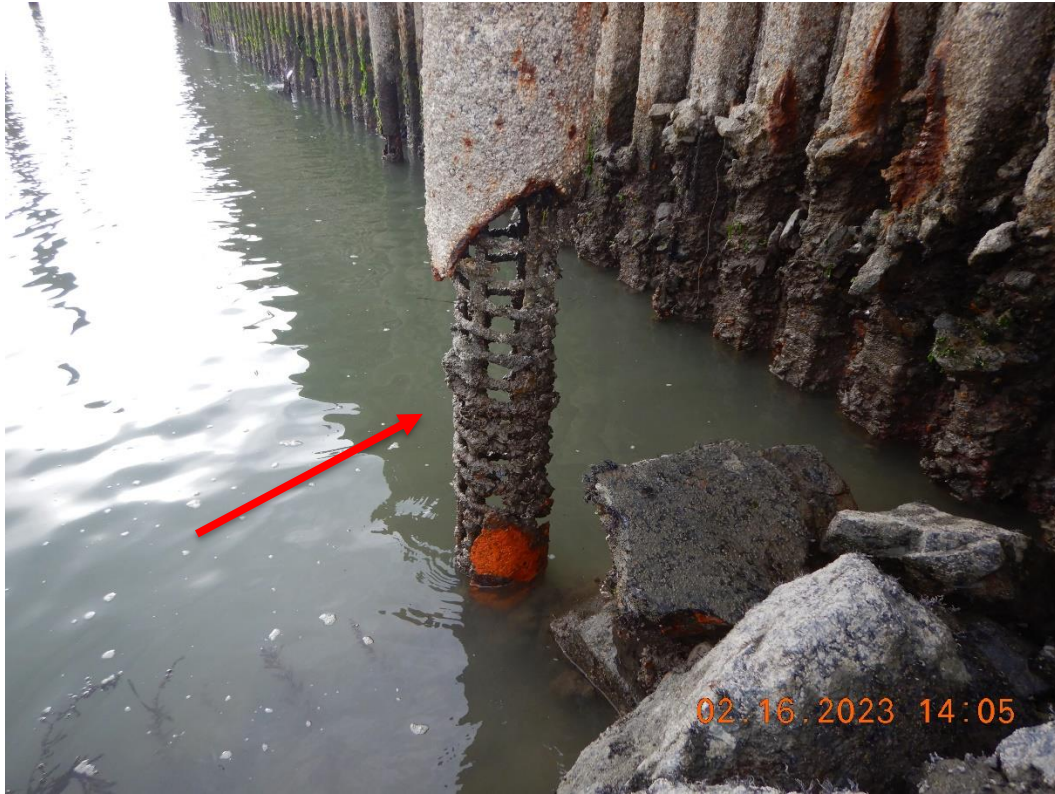
Photo 11. Severe corrosion at platform support pile at STA 3+00

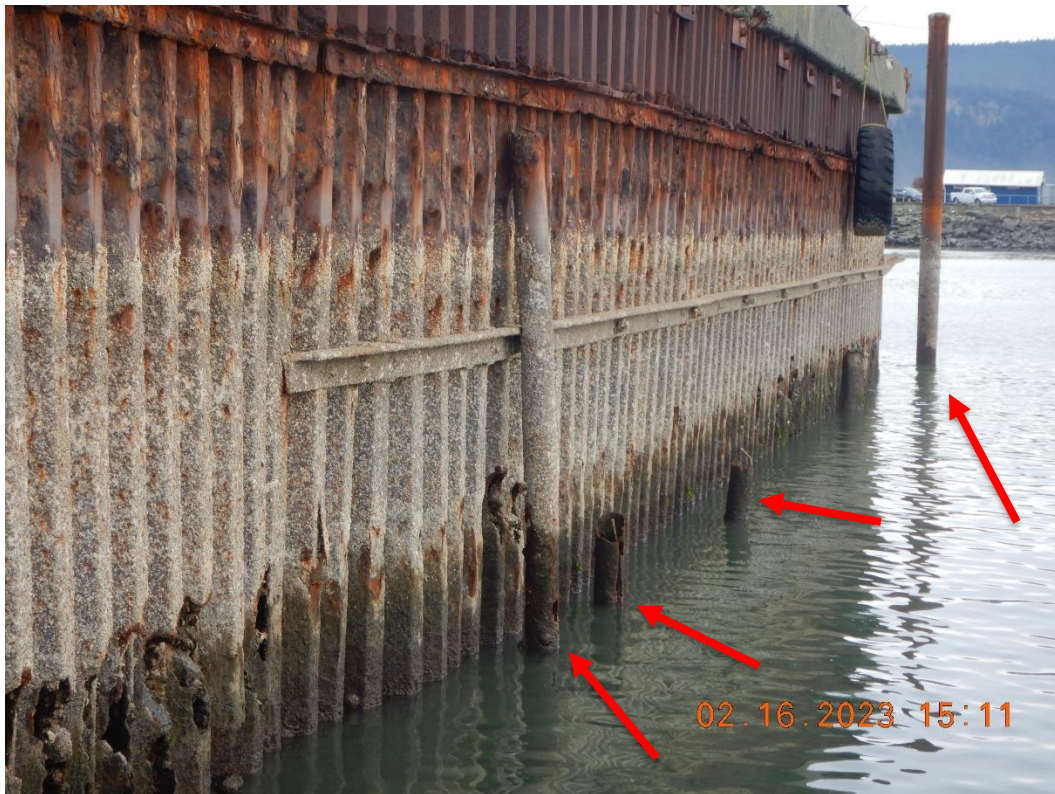
Photo 12. Typical broken fender pile remaining along bulkhead

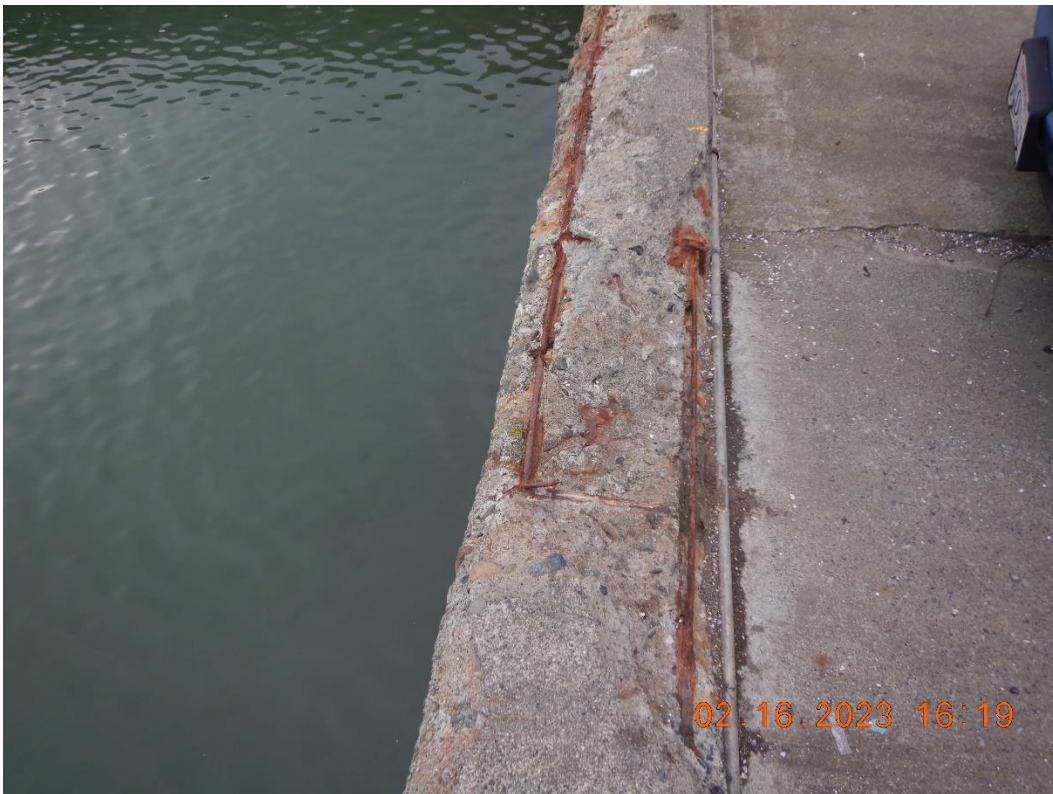
Photo 14. Severe open corrosion spalling (OCS) with exposed and corroding reinforcement from STA 0+43 to 0+70

0+43	0+65	OCS TOP EDGE OF CAP	MJ	22'	4"	4"	EXPOSED BAR
0+49	0+70	OCS AT TOP OF CAP WITH SECTION LOSS OF EXPOSED BARS	MJ	21'	12"	6"	UP TO 50% SECTION LOSS OF EXPOSED BARS
0+50	-	CORROSION HOLE IN SHEET	SV	5"	12"	-	ABOVE UPPER WALE
0+55	-	DEEP VOID	SV	-	48"	72"	
0+60	0+67	SUBSIDENCE OF CONCRETE PAD	MD	84"	15'	4"	
0+74	-	PIPE PENETRATION IN BULKHEAD	ND	4"	4"	-	
0+95	-	SHEAR CRACK IN CAP	MD	48"	1/8"	-	
1+00	1+50	ISOLATED CORROSION HOLES	SV	50'	42"	-	
1+00	2+00	CORROSION HOLES ABOVE UPPER WALER	SV	100'	6"	-	
1+00	2+00	CORROSION OF LOWER WALER	MN	100'	-	-	
1+08	-	STEEL PLATE WITH 1.5" DIA. BOLTS	-	-	-	-	
1+10	-	BROKEN CLEAT	SV	-	-	-	
1+17	-	STEEL PLATE WITH 1.5" DIA. BOLTS	-	-	-	-	
1+20	1+40	OCS SOFFIT EDGE OF CAP	MJ	20'	4"	4"	EXPOSED BAR
1+25	1+35	CCS AT TOP AND SIDE OF CAP	MD	10'	-	-	
1+37	-	STEEL PLATE WITH 1.5" DIA. BOLTS	-	-	-	-	
1+37	-	CORROSION AT CLEAT	MN	-	-	-	
1+48	-	STEEL PLATE WITH 1.5" DIA. BOLTS	-	-	-	-

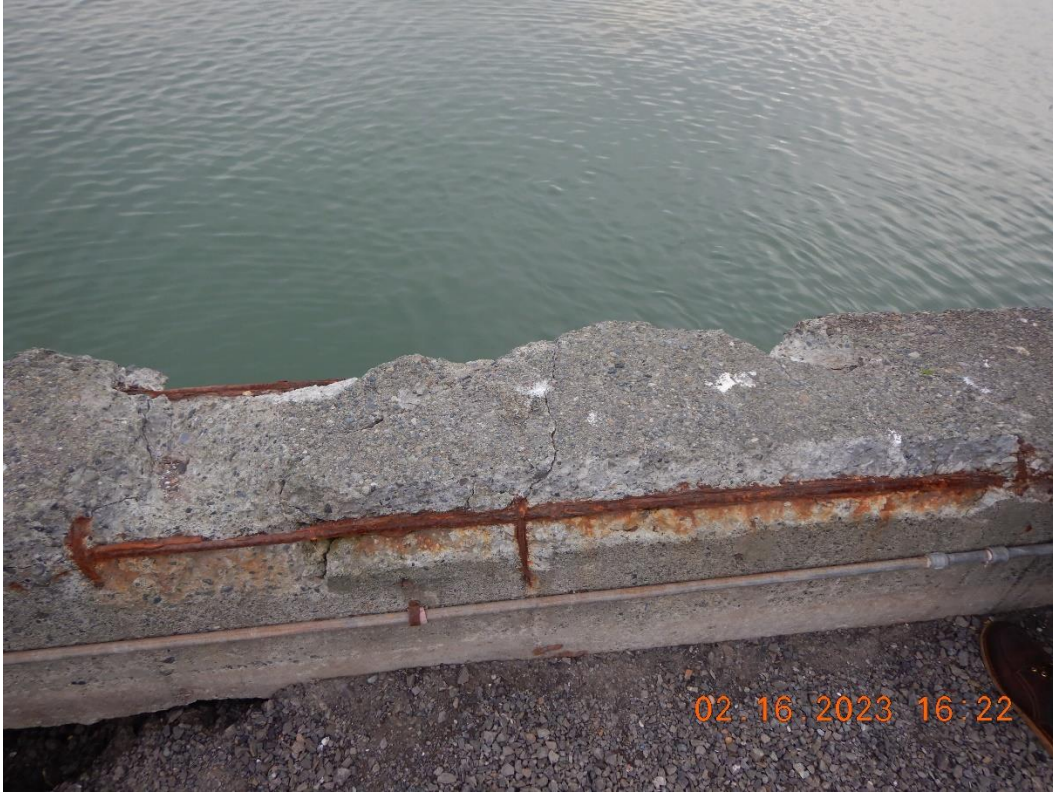
Photo 15. Severe OCS with exposed and corroding reinforcement from STA 1+70 to 1+90

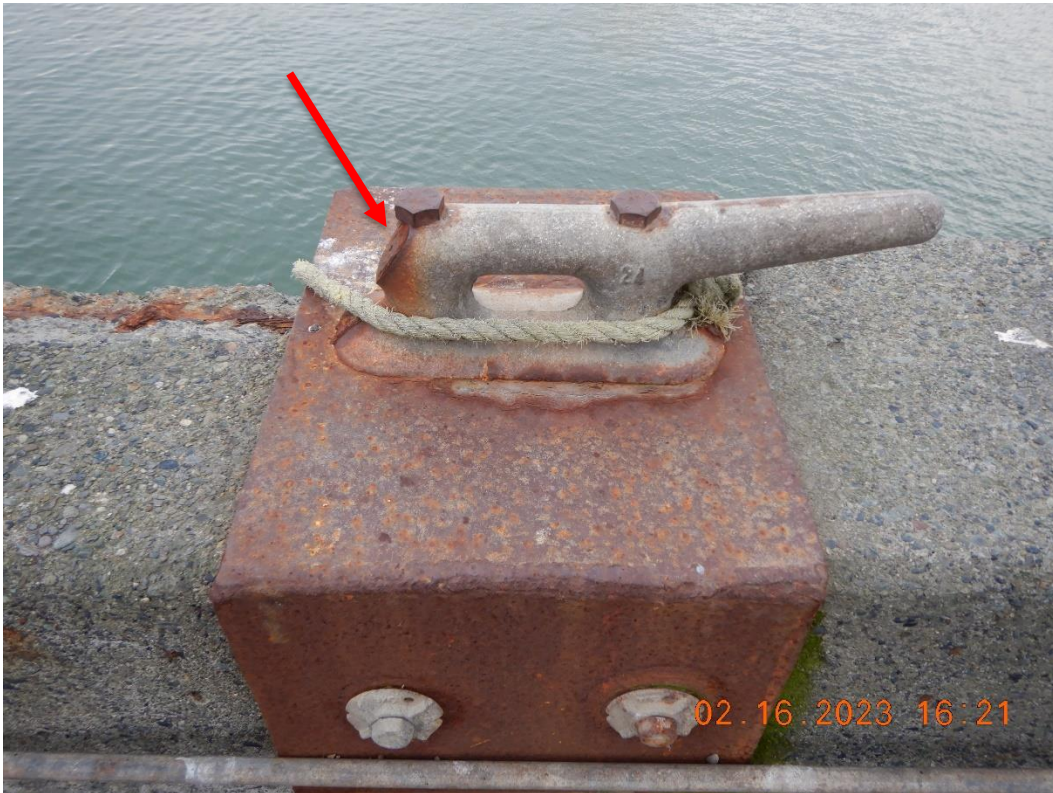
Several of the mooring cleats have severe damage with broken horns.

Photo 16. Broken mooring cleat horn at STA 1+73

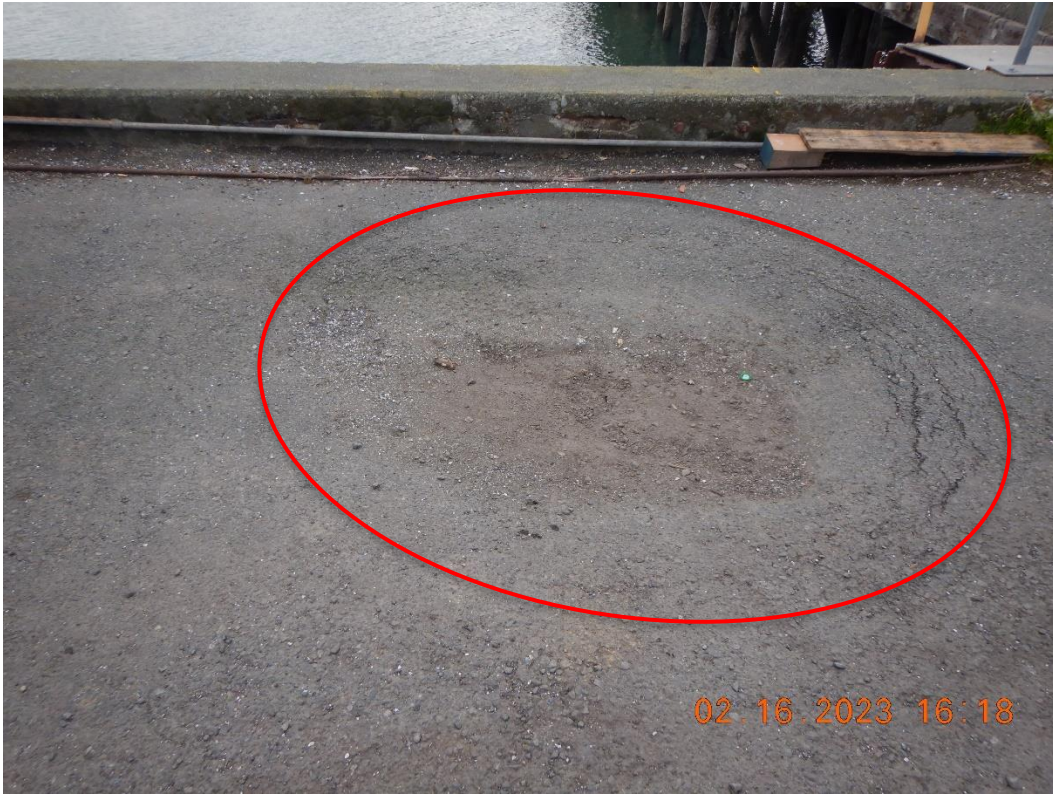
Photo 17. Moderate sinkhole in asphalt paving at STA 0+12

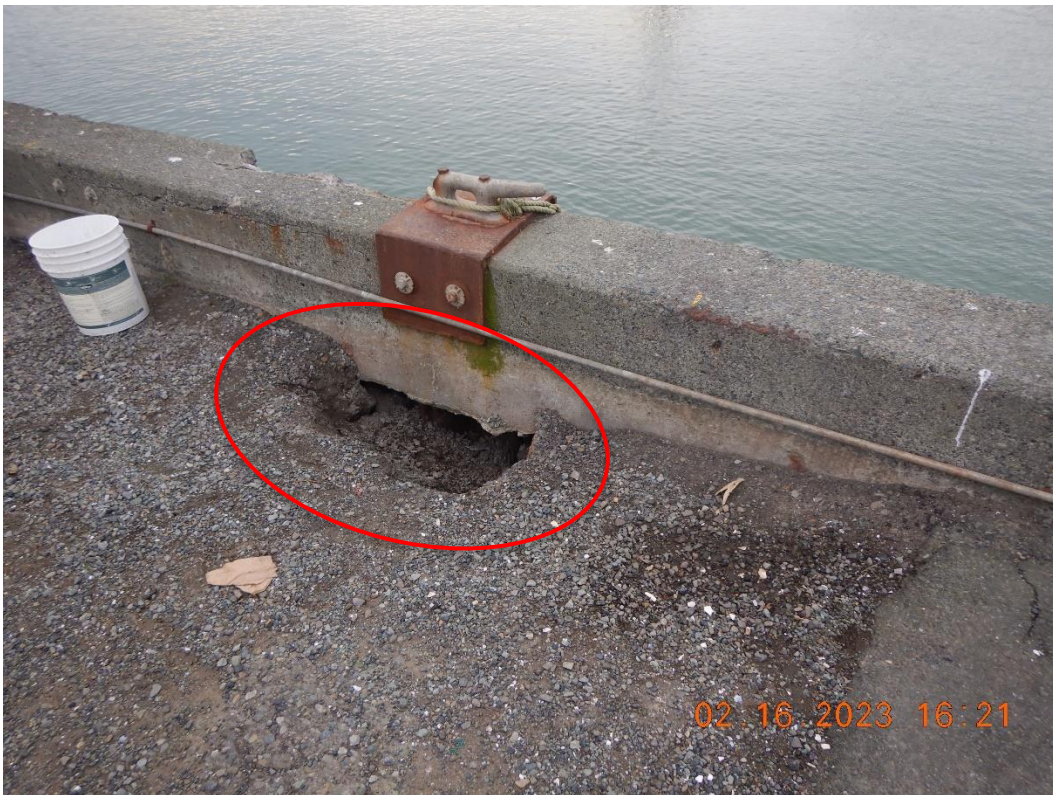
Moderate to severe sinkholes/subsidence of up to 18 inches deep were observed along the length of the bulkhead. The severe sinkholes have exposed the backside of the steel sheet piles and cap tie-rods. The concrete pad adjacent to the bulkhead appears to have subsided approximately 4 inches.

Photo 18. Severe sinkhole at STA 1+73

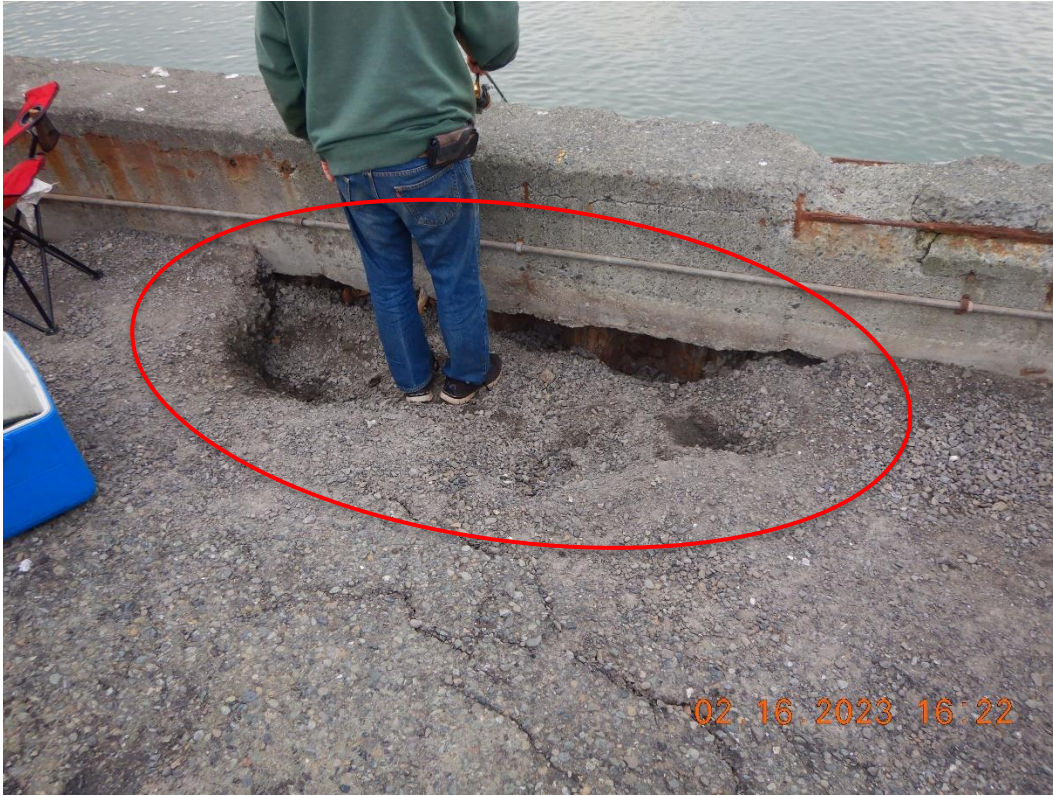
Photo 19. Severe sinkhole at STA 1+90

STATION		DEFECT	DEFECT RATING	DEFECT DIMENSIONS			COMMENT
START	END			HEIGHT / LENGTH	WIDTH	DEPTH	
1+90	-	SINKHOLE IN BACKFILL	SV	96"	36"	18"	EXPOSED CAP TIE ROD
1+98	-	SINKHOLE IN BACKFILL	SV	24"	6"	6"	
2+00	-	LOWER WALER DISCONNECTED AT CORNER	SV	-	-	-	
2+00	3+00	SECTION LOSS OF UPPER WALER/HARDWARE UP TO 50% LOSS	SV	100'	-	-	
2+00	3+00	CORROSION HOLES IN SHEETS, APPROX. 10% OF SHEETS	SV	12"	6"	-	TYPICAL CORROSION HOLE SIZE
2+00	3+00	CORROSION HOLES ABOVE UPPER WALER	SV	100'	6"	-	
2+00	3+00	CORROSION AT LOWER WALER	MN	100'	-	-	
2+31	-	OCS AT TOP OF CAP	MJ	8"	3"	1.5"	EXPOSED BAR
2+50	2+80	SINKHOLE IN BACKFILL	MD	30'	96"	6"	BACKFILL SUBSIDENCE
